THE APRIL 2016 MUISNE (ECUADOR) EARTHQUAKE – BEHAVIOUR OF LOW-RISE RC FRAMES WITH MASONRY INFILL, AND RECOMMENDATIONS FOR NEW CONSTRUCTION

Sebastian KAMINSKI¹, Tom SCHACHER², Jorge LOPEZ³, Guillermo FRANCO⁴, Carlos MOLINA HUTT⁵, Guillaume ROUX-FOUILLET⁶, Nadia CARLEVARO⁷, Harriette STONE⁸

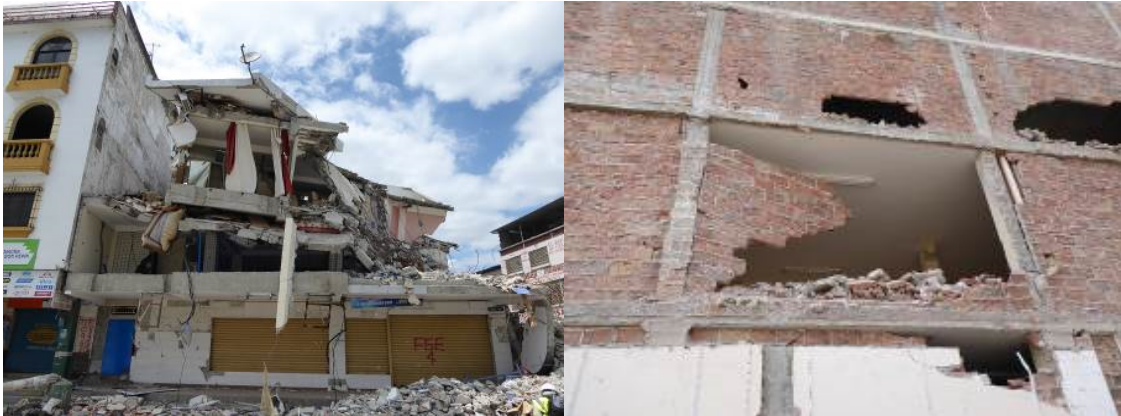
Damaged RC framed structures generally contained some or all of the following issues (Figure 3):

- Inadequate global flexural and shear capacity.
- Strong beam – weak column.
- Lack of capacity design in beams (necessary to ensure a ductile flexural failure mode occurs before a brittle shear failure mode).
- Inadequate detailing for strength and ductility.

Figures 3 and 4. Collapsed building showing failure of frame, and masonry failure out-of-plane.

The masonry used to infill RC frames to provide façades and partition walls was inadequate in a number of areas (Figure 4):

- The connections between the columns and the masonry were often insufficient to prevent out-of-plane wall failure. In most buildings no reinforcement bars connected the infill to the frame, or the masonry was offset from the RC frame.

- Where reinforcement bars did exist connecting the columns to the masonry, the masonry was often too thin and the mortar too poor quality to enable the bars to properly bond to the masonry. In addition, the thin mortar meant the bars were not properly protected against corrosion.

- In order to save construction time and material costs, the RC beams and columns were placed far apart, and the walls were single skin and constructed by placing bricks laid on the long narrow side (with the broad face of the brick exposed). This creates a very slender aspect ratio of the panels, which means that the masonry is unable to arch under out-of-plane load, nor able to provide a stable response under in-plane load, and therefore is liable to fail/buckle out-of-plane (Goretti *et al.*, 2017).

- Where the designated lateral load-resisting system is a moment frame, the masonry should be de-coupled from the frame through the introduction of a 'soft' joint on three sides of the masonry panel (typically 10-40mm thick), filled with a compressible material. This 'best-practice' was not observed in any building.

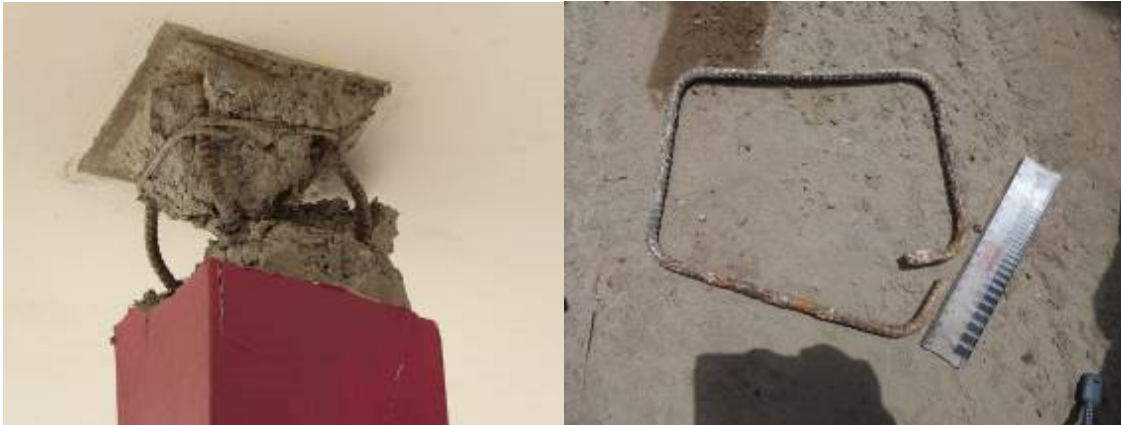
In seismic areas, the shear links within RC elements need special detailing. In particular, shear links need to be closely spaced, the two ends of the loop need to return into the column by an angle greater than 135 degrees, and the length of the returns need to be sufficient. This detailing ensures that the shear capacity of the concrete is as designed, helps to reduce buckling of the longitudinal bars and helps to confine the concrete in the core. In many RC buildings surveyed, some or all of these detailing requirements were not present (Figure 5 and 6).

Figures 5 and 6. Inadequate design and detailing for shear –link spacing and detailing.

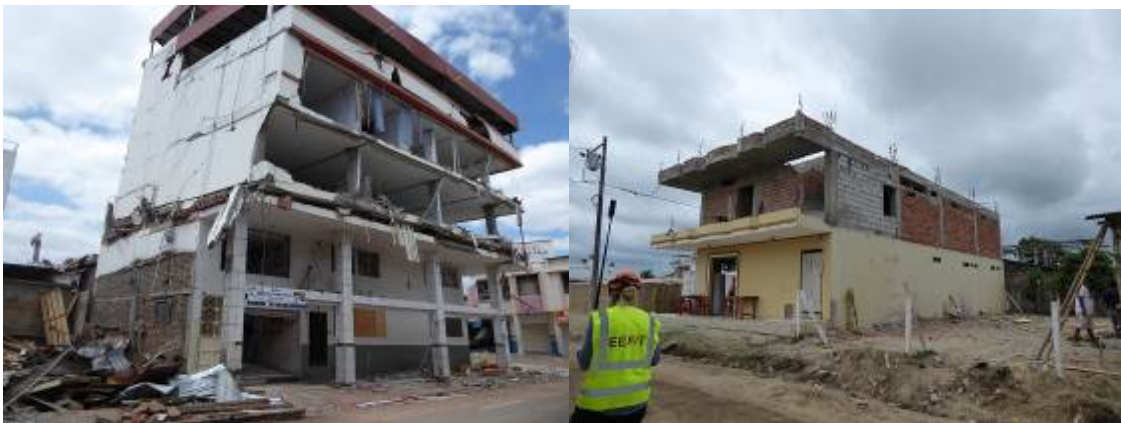
Upper floor soft/weak storey failures occur when a floor is lower in strength or stiffness than the adjacent storeys, resulting in load concentration at this floor level, which can exceed the capacity and result in damage to or collapse of that floor (Figure 7). This form of collapse was seen in a number of buildings, interestingly many of which were at an upper floor instead of a ground floor (which is generally more typical). Some of the soft/weak storey failures were likely due to a discontinuity in frame and/or masonry strength between floors, while it is suspected that others were due to inadequate lapping of primary column reinforcement (see item (E) Inadequate laps).

Figures 7 and 8. Weak/soft storey failure, and exposed reinforcement with possible inadequate lap lengths for future construction.

A number of buildings experienced upper floor weak/soft storeys without a clear change in stiffness or strength. It is known that the reinforcement bars come in set lengths, and when placed for construction the top of the bars were often observed to rise just above the second floor. It is common to build just two storeys initially and leave extra reinforcement exposed, ready for an additional floor in the future (Figure 8).

In many cases, the amount of reinforcement sticking out waiting for future construction may not be sufficient for a proper reinforcement lap, which would lead to a weak and brittle connection between two distinct phases of construction. In addition, the reinforcement bars are often left out for many years and so can experience surface corrosion, which can weaken their bond to the new concrete once poured. Finally, all of the rebar is often lapped at one height, causing potentially weak spots in the same location in all columns on a given storey. This can cause specific floors to be weaker relative to those above or below.

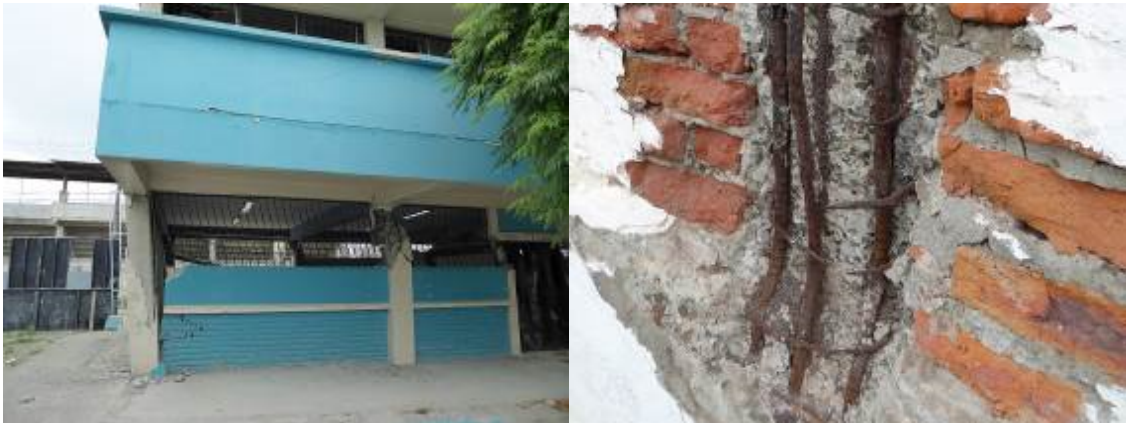
This failure occurs when partial height stiff walls are constructed against columns. This construction promotes a brittle shear failure mode prior to a ductile flexural mode (Figure 9). This failure mode was seen in a number of buildings, with a reoccurring detail of elevated windows for the full length of the frame bays.

Figures 9 and 10. Short column failure and insufficient cover to rebar.

Sufficient cover to reinforcement is required to protect the reinforcement against corrosion. In coastal areas, the environment is more aggressive and the requirements for cover increase. In many columns, the cover was very low (0-20mm), which caused corrosion to the steel (Figure 10). For comparison, UK codes generally require around 50mm cover in good quality concrete to provide adequate protection in a coastal environment.

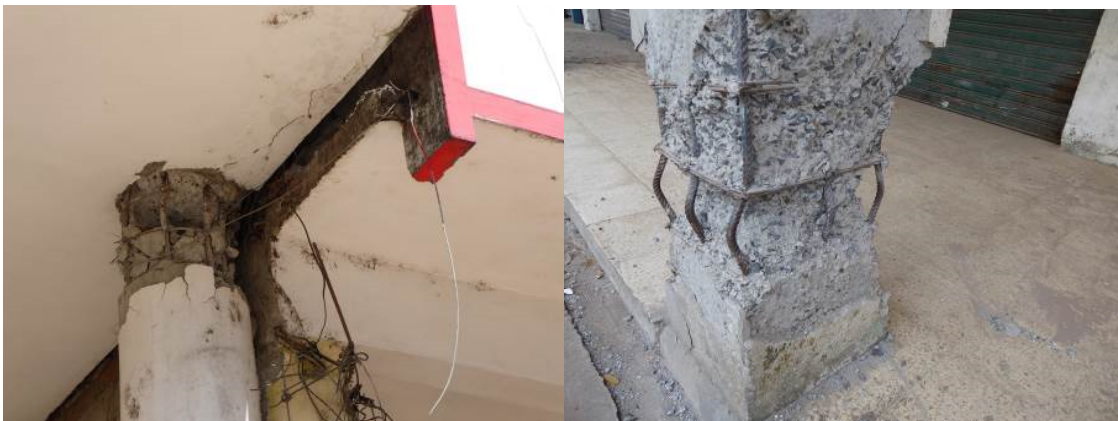
Pounding occurs when buildings move out of sync in an earthquake and impact on each other. In very few locations seismic gaps were seen in-between buildings and floor slabs were often out of alignment, leading to localised damage due to pounding (Figure 11).

Figures 11 and 12. Pounding of a column head by a slab of an adjacent building, and inadequate design of plastic hinges.

Designated hinges in RC elements require special detailing to ensure they yield in a controllable and ductile manner, as opposed to a brittle manner. Where hinges were seen, damage was often seen to be brittle, with failure mechanisms involving local concrete crushing and bursting, and buckling of longitudinal reinforcement, instead of pure tensile yielding of bars (Figure 12).

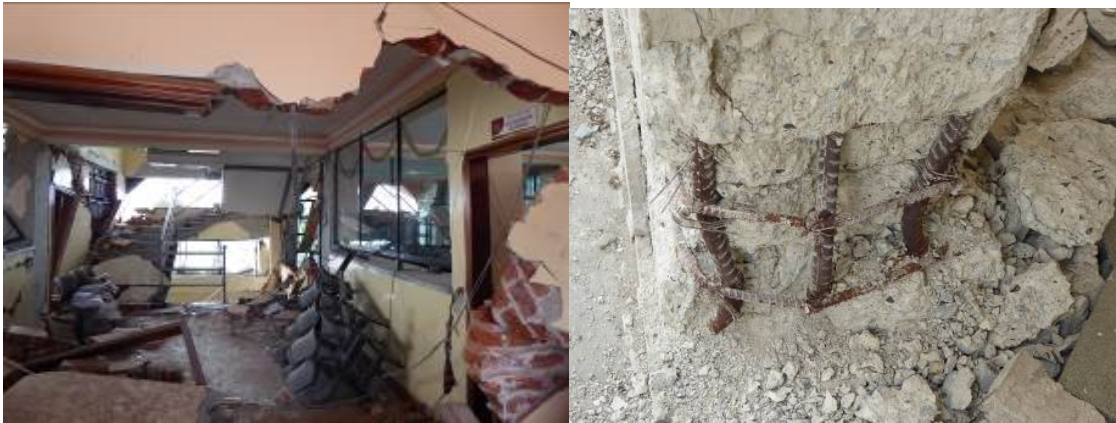
Non-structural elements require securing back to the structure in order to minimise injury and damage, to allow occupants to safely escape and in smaller earthquakes to permit continued building functionality after the event. Adequate securing of non-structural elements was rarely seen, with significant damage to facades, furniture, fittings and ceilings (Figure 13).

Figures 13 and 14. Inadequate securing of non-structural elements and poor quality concrete.

The concrete used in RC frames was observed to be of low quality in some areas (Figure 14), likely for a number of reasons:

- Inadequate mix design – some concrete clearly had too much or too little coarse aggregate.
- Excess water – with informal construction, it is common to add excess water to the mix to improve workability, which weakens the concrete.
- Poor compaction – some concrete clearly had not been properly compacted and voids were evident at the bottom of pours.
