## **OBSERVATIONS FROM THE EEFIT-TDMRC MISSION TO SULAWESI, INDONESIA TO INVESTIGATE THE 28<sup>TH</sup> SEPTEMBER 2018 CENTRAL SULAWESI EARTHQUAKE**

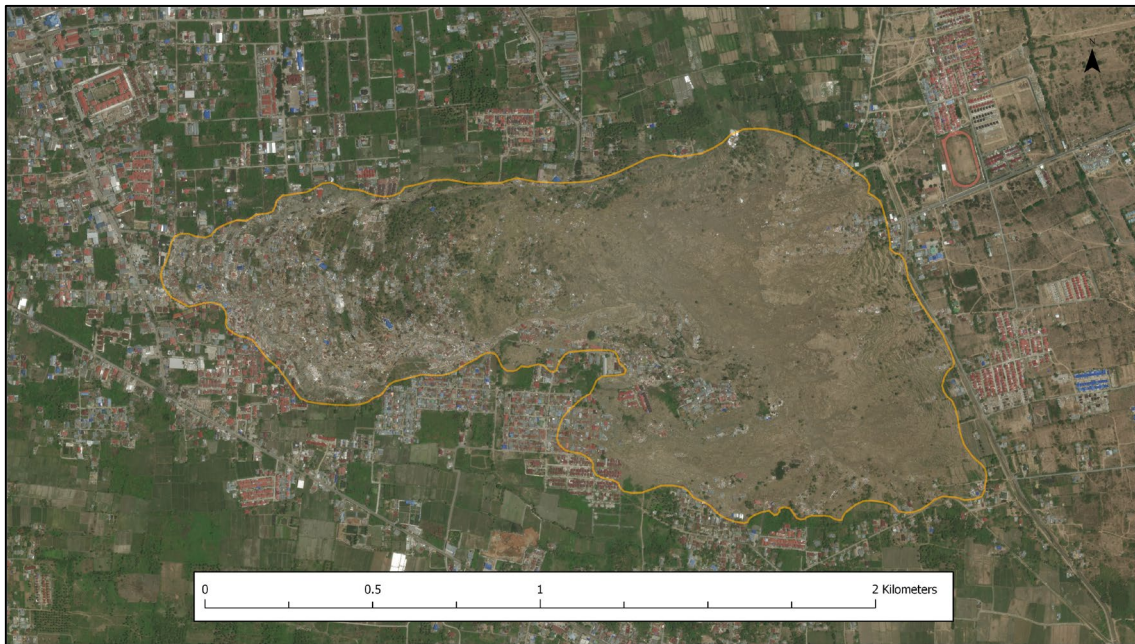
The three main landslides that occurred following the earthquake are considered to be low-angle liquefaction-induced debris flows that were extremely mobile due to significant water content. The causal factors are largely thought to be related to the hydrogeological regimes' interaction with the topography as well as possible anthropogenic factors. Most notably, a man-made irrigation channel running along the eastern side of the valley (Figure 1) appears to be the initiation point of the two largest landslides, including at Petobo (Figure 4), with evidence suggesting the underlying hydrogeological regime is significantly affected by its presence (Figure 5). Whether or not the irrigation channel alone directly led to the failures is cause for discussion, but it is likely at the very least that it contributed to the long runouts due to the significant volume of additional water introduced into the ground.

Figure 4. Satellite imagery showing extent of Petobo landslide area (Imagery: Digital Globe, 2018).

Further investigation is needed to establish a clearer picture of the landslide causes and mechanisms, ideally with some detailed intrusive geotechnical investigation. This will provide information on which to design potential mitigation options, such as drainage infrastructure and modifications to irrigation systems.

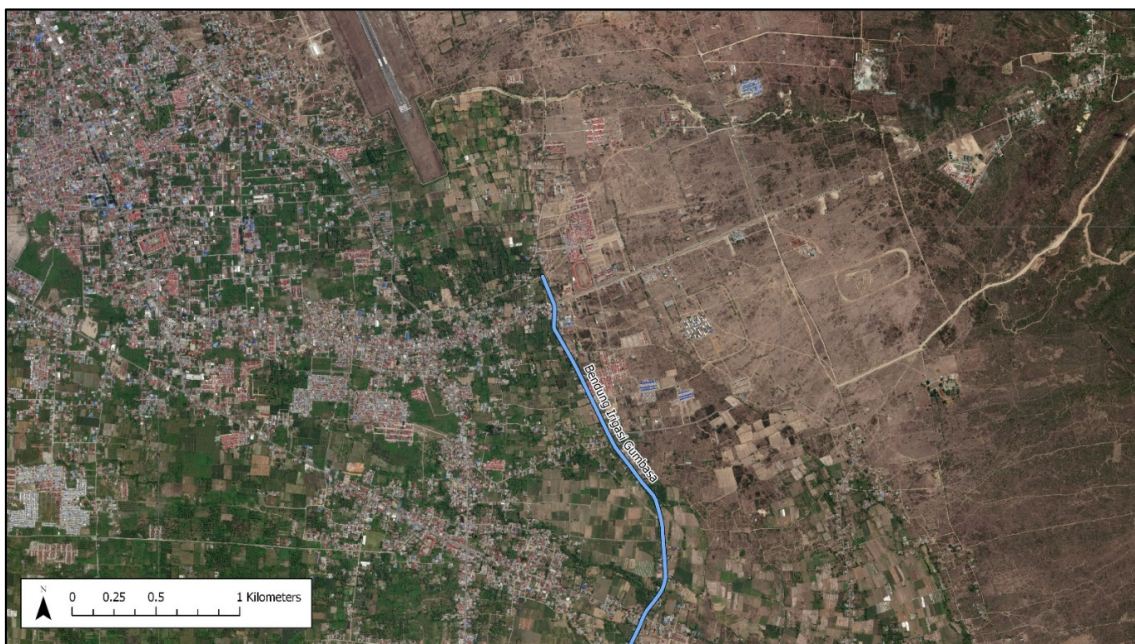
Figure 5. Difference in vegetation growth due to groundwater conditions on either side of the Bendung Irigasi Gumbasa. Green vegetation growth (left) indicates wetter ground conditions as opposed to brown land with lack of vegetation growth (right) indicating mostly dry ground.

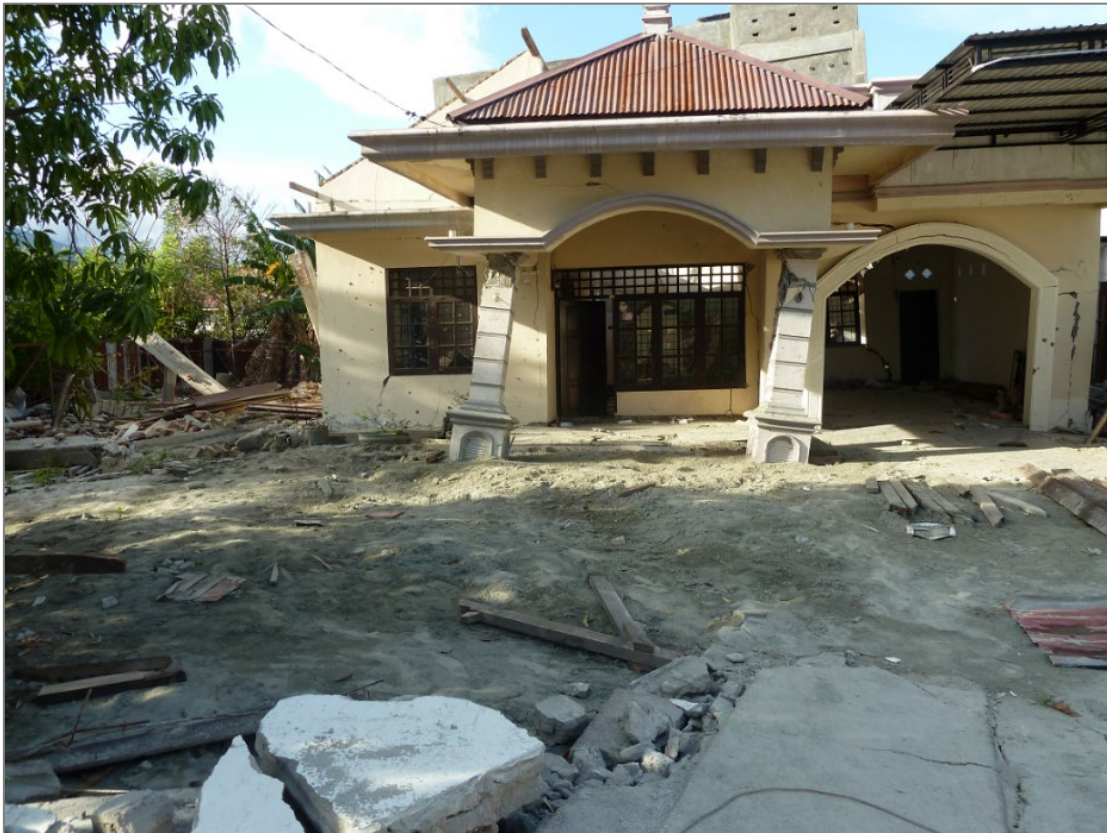
- “Conventional”, localised liquefaction-induced settlements and tilting of individual structures, with associated ejecta features (Figure 6). These seemed to affect a small number of isolated areas.
- Liquefaction of seafront areas near estuary mouths, resulting in significant areas of land mass slumping into Palu Bay (Figure 7). The Team identified areas on both sides of Palu Bay affected by this. It is possible that some of the reported coastal inundations were caused by backwash over these slumps.

Figure 6. Damage to a one-storey building in Lasoso due to differential settlement induced by liquefaction. Sandy ejecta in garden.

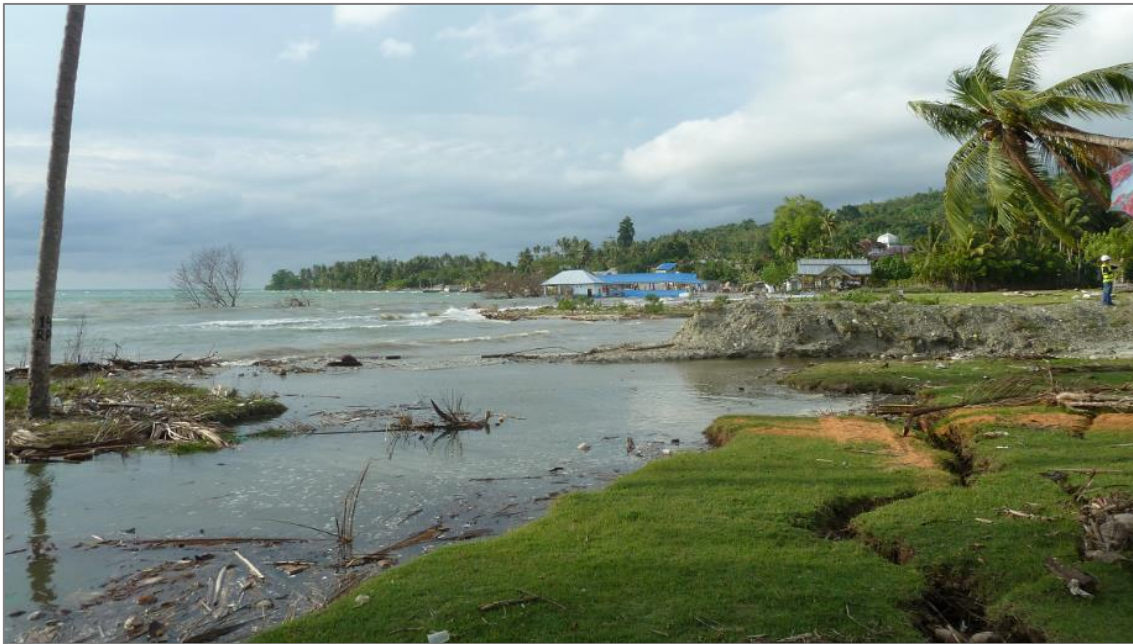
The team identified areas on both sides of Palu Bay affected by seafront loss due to liquefaction. The EEFIT-TDMRC observed this at Loli Tasiburi on the Western shore and at Lero on the Eastern coast. Locals at Loli Tasiburi reported that large areas of coastline had broken off and fallen into the sea, with one indicating Palu, visible in the distance around a headland, which he reported had previously been obscured by the land. An eyewitness described the soil “bubbling”, and two large upwards spurts of water on the beach. The soil type and inevitable high groundwater level suggest liquefaction was a clear possibility, and the eyewitness reports are consistent with soil liquefying. The team concluded that liquefaction had therefore occurred in the coastal soil, and either the resultant large settlements were sufficient to submerge the coastal land or (more likely) lateral spreading has taken the shoreline into the bay.

Figure 7. Area of land lost to coastal slumping due to liquefaction at Lero.

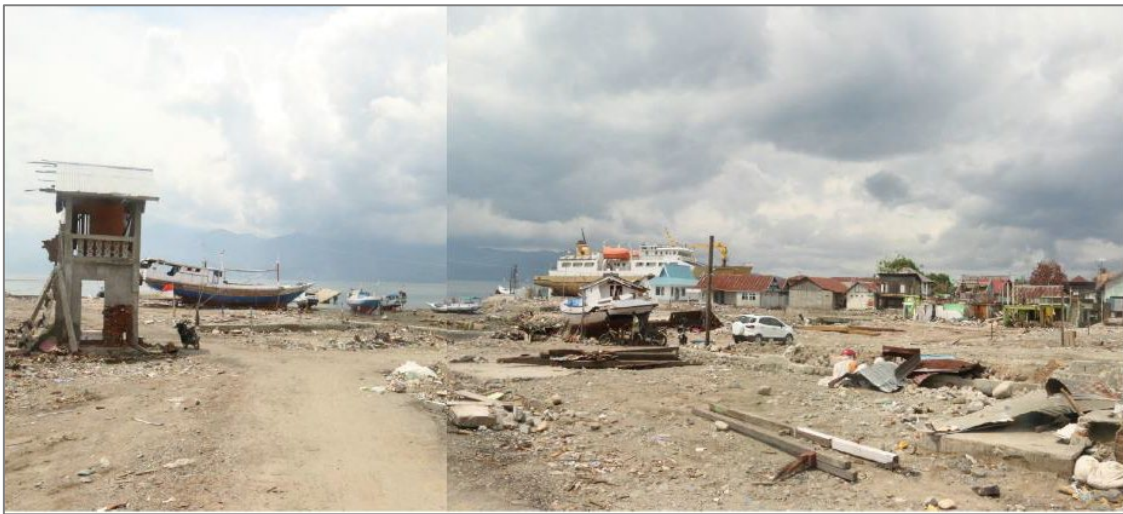
Despite causing considerable damage along the shoreline (Figure 9), the horizontal inundation of the tsunami was relatively modest. This is an indicative characteristic of landslide generated tsunamis. There was no evidence of the tsunami having travelled up the Palu river at the southern end of the bay, which is in contrast to what has been found on previous EEFIT missions e.g.

Figure 9. Wani village on the east coast of Palu bay which experienced considerable damage.

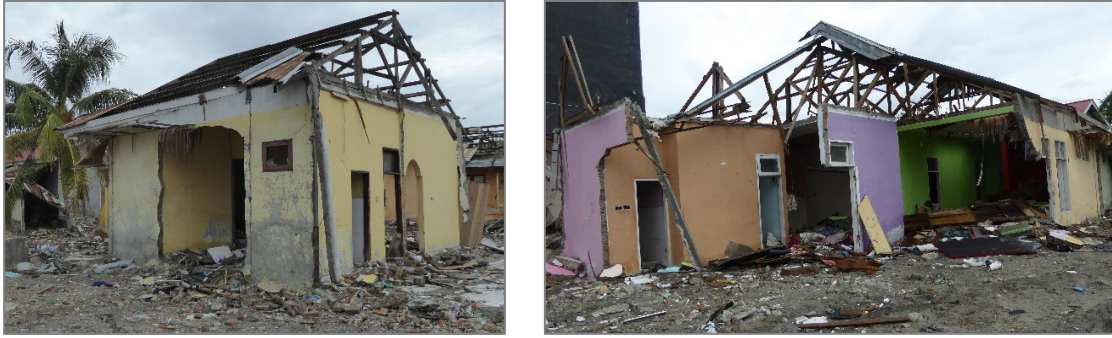
The most common non-engineered construction observed in Palu is confined masonry (CM). Typical damage sustained by CM houses along the coast line in Palu bay area is shown in Figure 10. The main damage pattern is the out of plane failure of walls directly hit by the tsunami waves. In the case of earthquake ground shaking the weak materials used for both the masonry and confining elements resulted in out-of-plane failure of the masonry and cracking and failure of tie-columns.

Figure 10. Heavily damaged CM houses in Palu bay area along the Jl. Rajamoili road, about 100m from coastline. The walls of this house were directly hit by the tsunami inundation.
