# NEWSLETTER

Volume 28 No 1  
March 2017

## EEFIT Special Issue

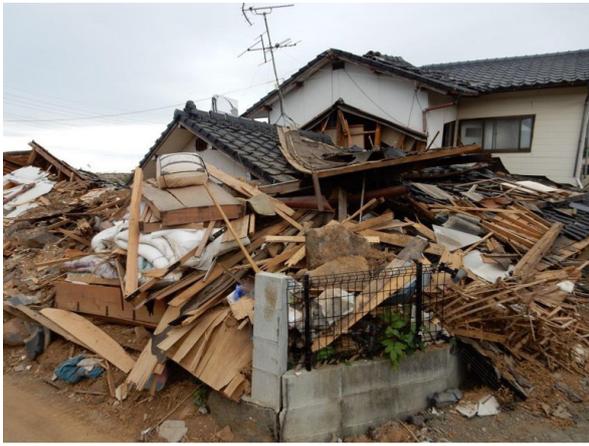
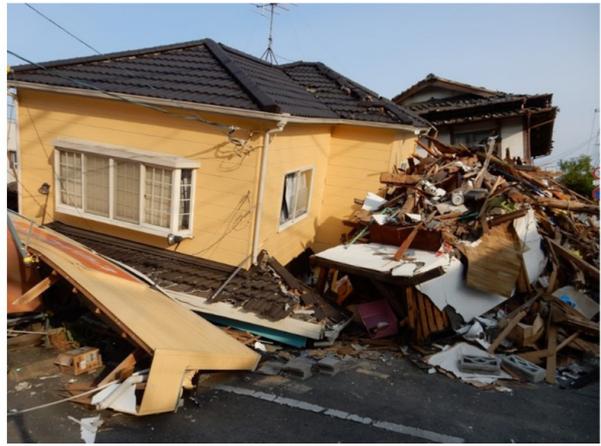
In general, damage survey data and observations indicated that the majority of the collapsed buildings were timber houses with heavy roof tiles, which were constructed according to the pre-1981 seismic design provisions (Nakashima and Chusilp, 2003; Figure 4). Typically, reinforced concrete (RC) buildings performed better than older steel and timber buildings (Figures 4, 5 and 6). The moderate and heavy damage to RC buildings was in the form of shear cracking to RC shear walls and joint damage to poorly detailed RC frames, in addition to less frequently observed partial and extreme soft-storey collapses. Several

**Figure 4: Damage to timber frame houses, (a) complete collapse of pre-1981 structure, and (b) an example of storey collapse.**

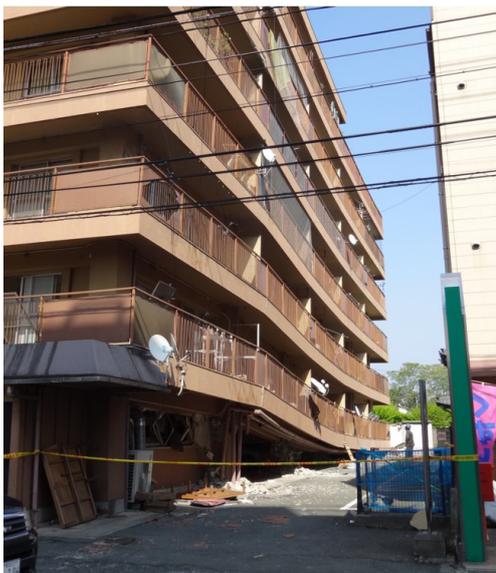
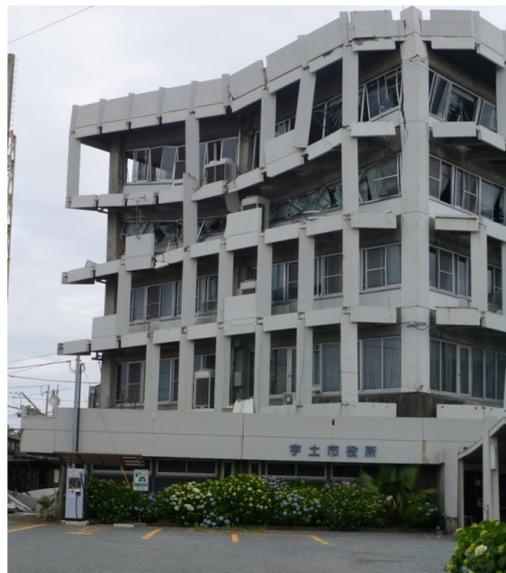
**Figure 5: Damage to RC frame buildings; (a) soft-storey collapse of an apartment building (Tajiri et al., 2016), (b) west façade of the Uto City Office.**

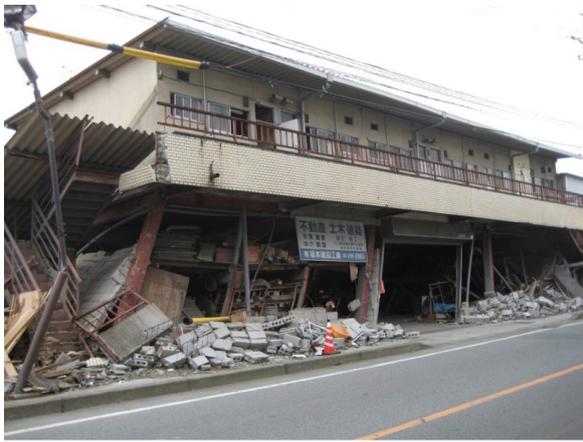
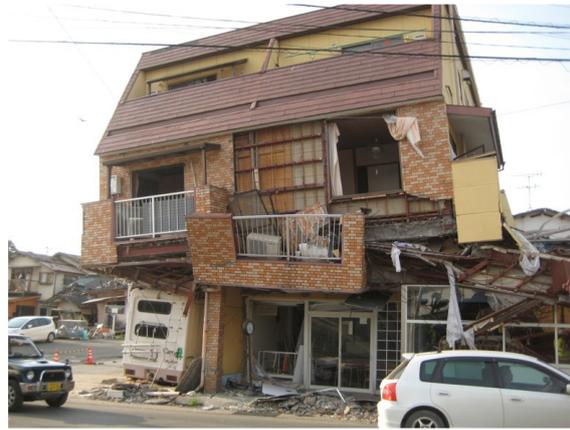
**Figure 6: Steel building failures Mashiki Town: (a) bottom-storey drift; (b) four-storey collapse.**

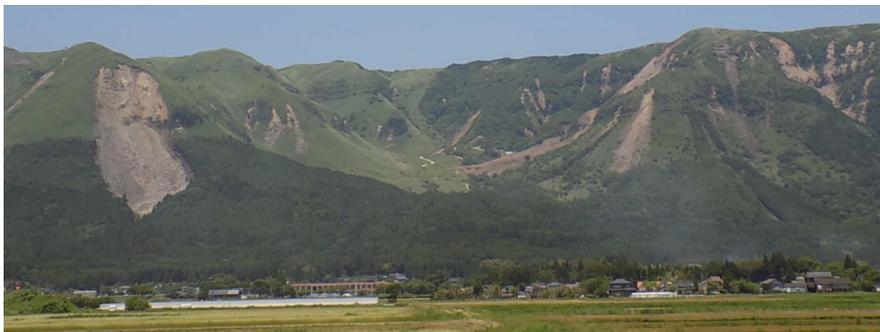
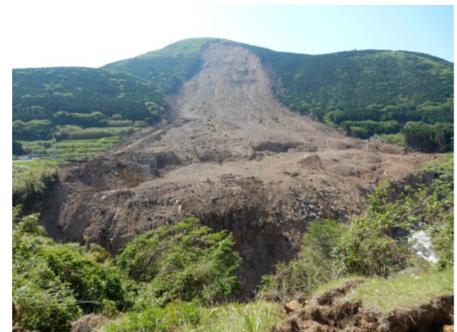
In terms of geotechnical failures, many significant bridges, embankments, retaining walls, tunnels and a dam were damaged by slope failures, lateral spreading, settlement, and landslides mostly in the high-relief region of Aso (Figures 2b and 7). This is where the Futagawa fault intersects with the west wall of the Aso volcanic caldera. Liquefaction effects were observed, in the form of ejected sand at Kumamoto Port (which is an artificial island), and in the form of settlement, lateral spread, and uplifted drain covers along the roads that cross the alluvial plains close to

**Figure 7: (a) Landsliding in the high-relief Aso Caldera region at the east extent of the main Futagawa fault; (b) the major Aso landslide that blocked the main road route between Kumamoto City and the rest of east Kyushu Island.**

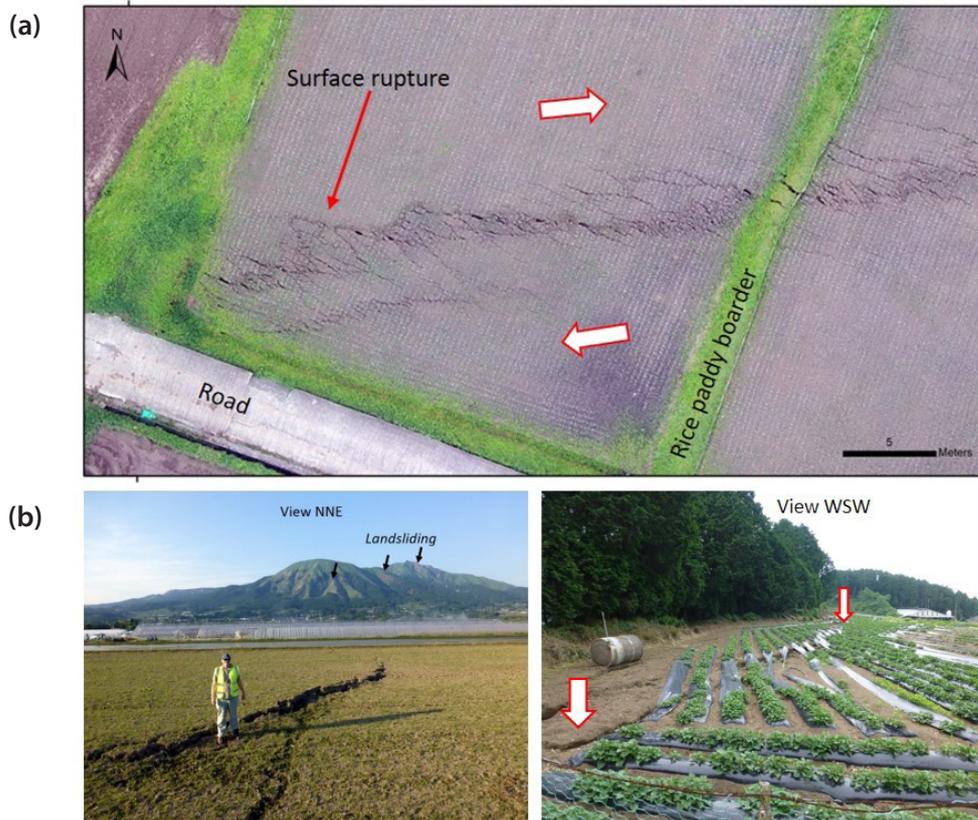
The mainshock earthquake generated two types of surface rupture (Figure 8): 1) right-lateral offsets related to strike-slip motion, and, 2) vertical offsets associated with extensional motion. The team made field measurements of the amount and type of offsets, in addition to carrying out an aerial-photo survey of a 300 m section of the surface strike-slip rupture using a drone. The aerial photos have been used to generate a high-resolution digital model of the surface rupture orientation and geometry. High resolution field and remote-sensing measurements such as this are important as they help us understand the scaling relationship between the fault surface offset and the earthquake moment magnitude.

Figure 8: (a) Aerial photo of the earthquake surface rupture right-laterally displacing (by ~2 m) rice paddy fields east of Mashiki Town, taken by the EEFIT drone; (b) examples of the surface rupture (~1.5 m) vertical offsets.

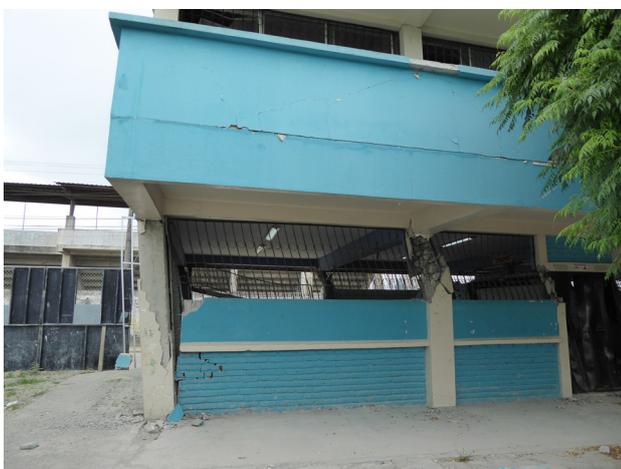
Lack of fundamental engineering design for lateral loads, including inadequate detailing, poor materials, irregularities, and seismic weaknesses such as short columns (see Figure 1), were observed as the primary causes of structural damage. Non-structural damage to the masonry infill walls was heavy, since many were slender and not tied into the RC frames (see Figure 2). Additionally, the lack of adequate maintenance to timber and bamboo structures induced some failures. Several instances of failures at upper levels were observed (see Figure 3), which were caused either by changes in stiffness in elevation, or potentially by poor connections between original buildings that had been extended vertically at a later date. It must be noted that demolition progressed rapidly, meaning that many of the worst damaged buildings had been removed prior to the team's arrival, and therefore surveys of these specific ones were not possible. However clear relationships were observed in the data collected, particularly between the spectral response derived from the recorded ground motions

**Figure 1: Short column failure to a school in Pedernales.**

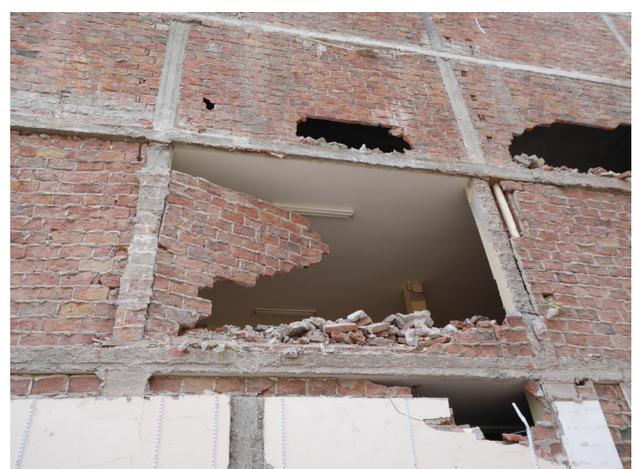
**Figure 2: Out-of-plane failure to slender and inadequately fixed clay brick masonry infill.**

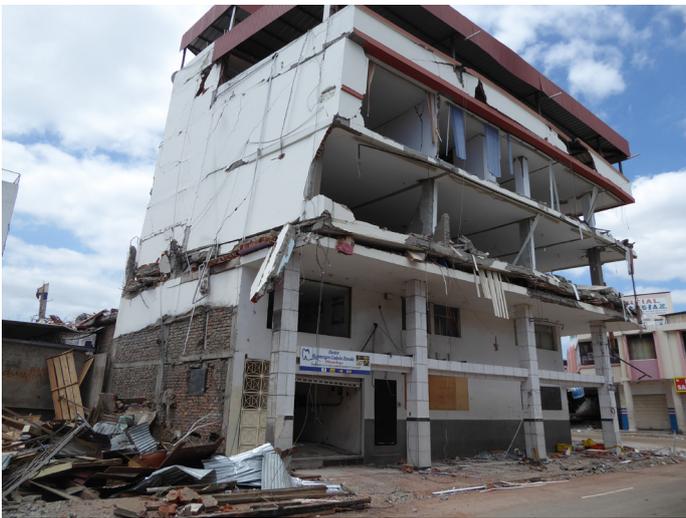
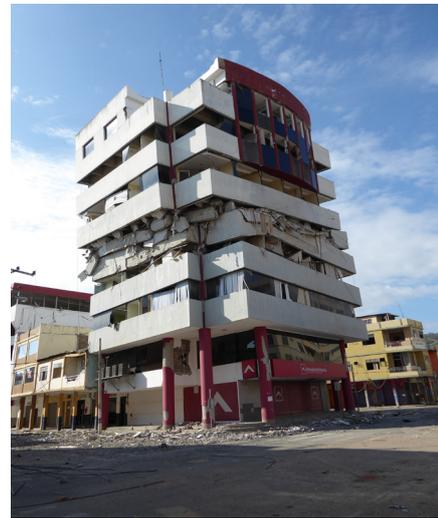
Figure 3: Upper level soft storey failures; (a) in Manta, and (b) in Portoviejo.

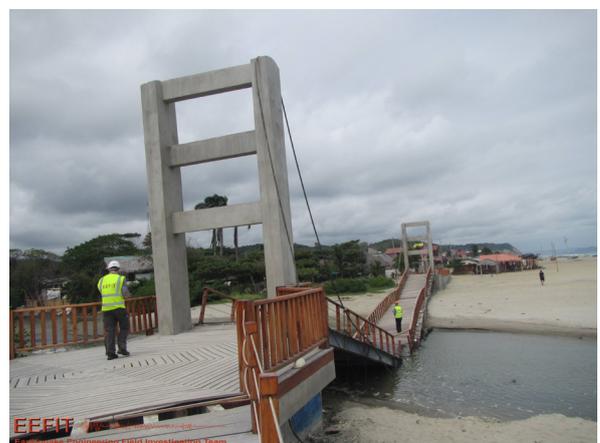
The team also surveyed a number of bridges. The base isolated Las Caras bridge which connects Bahía de Caráquez and San Vicente was found to have minimal damage, allowing it to remain operational throughout the humanitarian response. A suspension footbridge in Canoa was found to have collapsed following the failure of connections at the northern end and uplift of the anchor blocks at the southern end (see Figure 5).

Figure 5: Collapsed footbridge in Canoa.

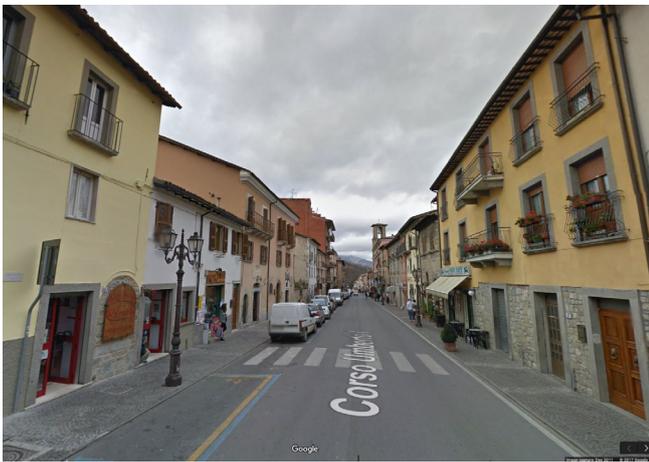
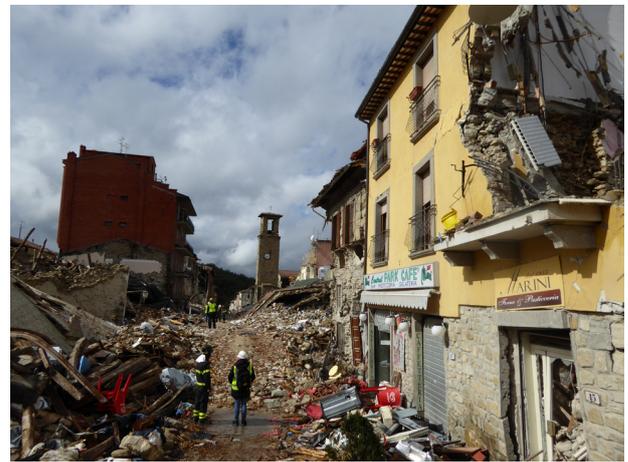
to heritage structures predominantly of masonry construction, and due to the occupancies in the areas affected much of the damage was to residential structures, with some commercial buildings in town centres. The historic centre of Amatrice, for example, was severely damaged and most of the 298 fatalities of the 24 August event occurred there. The damage level in Amatrice and certain other locations is extreme. The images shown in Figure 4 are a before and after image from approximately the same position.

**Figure 4: Amatrice's Corso Umberto I, (a) before (from Google Street view), and (b) after the earthquake.**

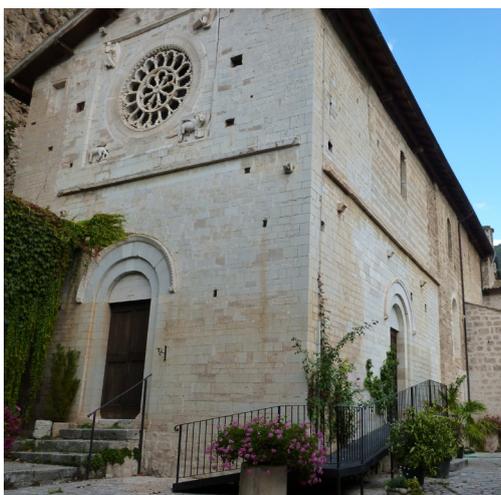
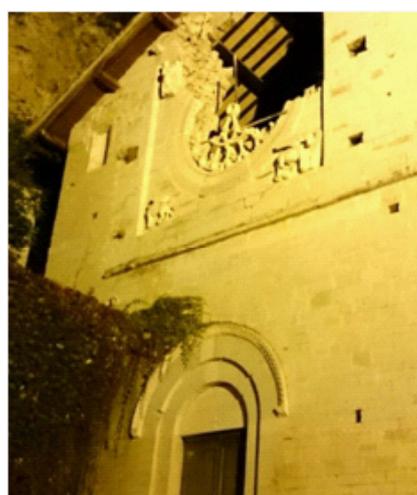
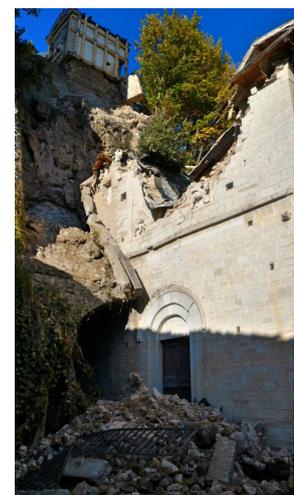
This latter aspect is relevant since two other destructive earthquakes on the 26th (Mw 6.0) and the 31st (Mw 6.5) of October struck the same area. The epicentres of these two events were close to Norcia municipality and located in the proximity of the churches inspected. Many of the heritage structures inspected during the mission collapsed dramatically after the subsequent earthquakes. There is evidence that some of the potential church collapse mechanisms identified during the mission were triggered by the subsequent earthquakes contributing to the structural failures; see for example Figure 5.

**Figure 5: St. Eutizio Abbey: façade gable mechanism as observed during the mission, after the 26th of October Mw 6.0, and after the 30th of October Mw 6.5.**

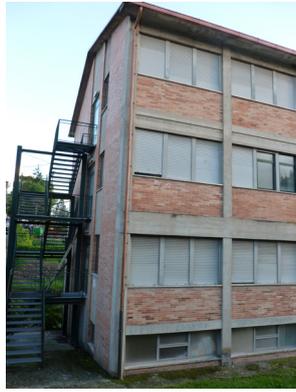
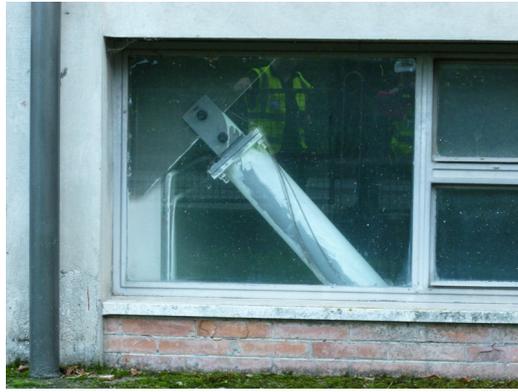
walls of the town of Norcia: a masonry and a RC building. While the first one was not in use and presented some damage, the RC building was functional. From the visual survey done by the team, damage to the masonry building was evaluated by the team as a damage state 3 according to the EMS-98 scale (Grüntal, 1998). The inspection on the RC building showed that even if it could be classified as a non-ductile RC dating designed before 1980, the school was subjected to a successful retrofitting intervention (probably after the 1997 Umbria earthquake) as highlighted by steel tubular braces at the first story (Figure 6).

Figure 6: (a) RC school building retrofitted after the 1997 earthquake; (b) closer view of retrofit.

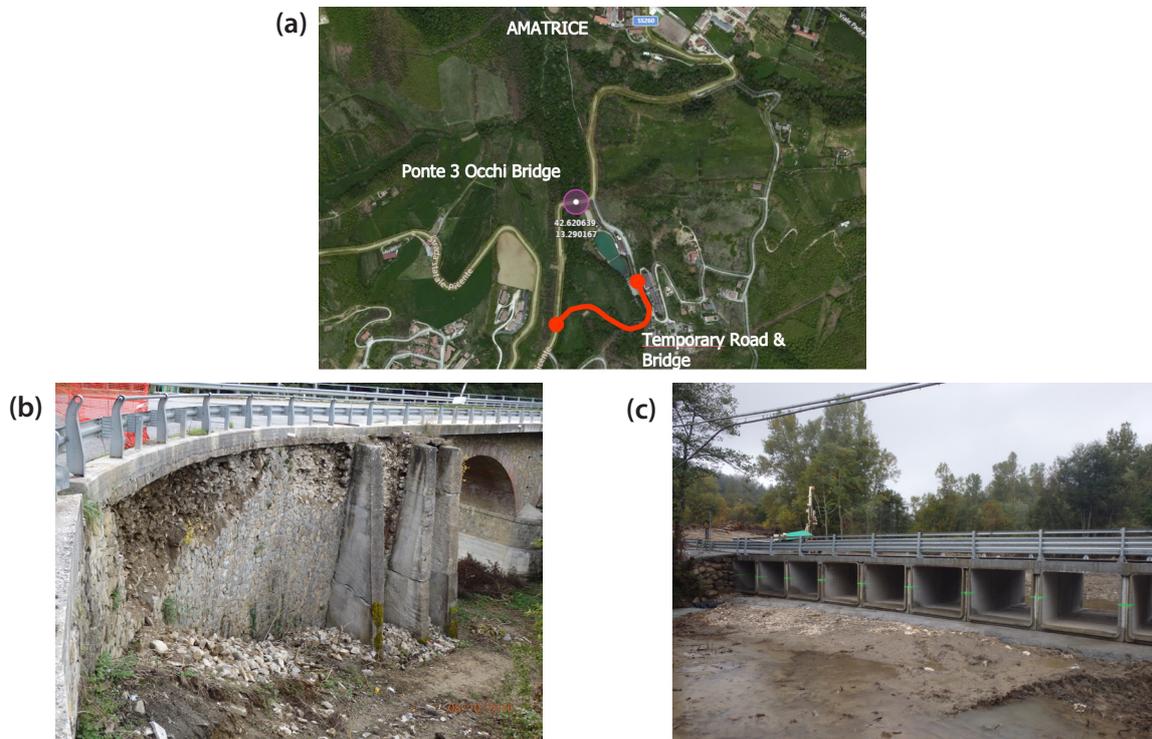
Finally the teams surveyed a number of bridges and critical infrastructures. Masonry arched bridges are the typology that suffered the most damage during the earthquake. One example is the "Ponte a 3 Occhi" bridge, a 70 m long structure located approximately one kilometre South of Amatrice (Figure 7). In the aftermath of the 24 August

earthquake, the bridge failure made national headlines as it was closed to traffic cutting off one of the key access routes for the emergency services. Its strategic importance was highlighted by the need for the army to construct a new by-pass road which was opened just over a week after the earthquake (Figure 7).

Masonry bridges closed to traffic suffered damage to the earth-retaining abutments suggesting that this particular structural element needs careful consideration in bridge seismic design. Masonry arches showed that they can perform their structural function even if they suffered damage, such as cracking, thanks to their inherent structural redundancy.

Figure 7: (a) "Ponte a 3 Occhi" bridge map, (b) damage to bridge, and (c) new by-pass road bridge.
