# NEWSLETTER

Volume 30 No 3  
December 2019

# Cultural Heritage Structures

# Seismic Retrofitting of Historic Earthen Structures in Peru

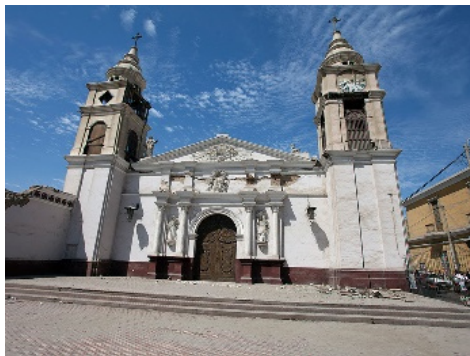
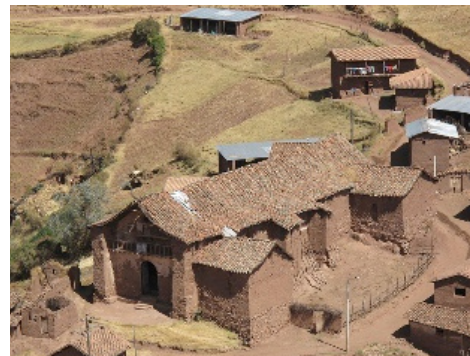
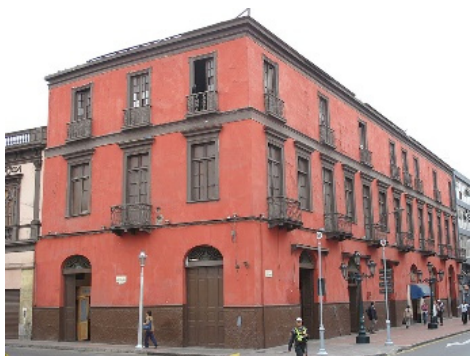
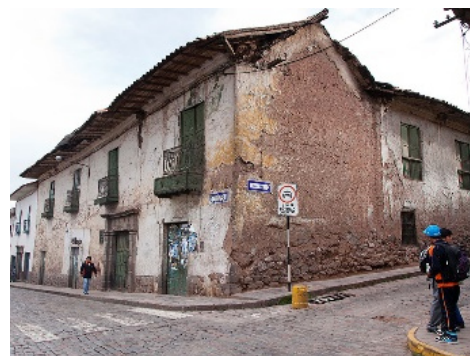
**Figure 1: Case studies: (a) Ica Cathedral; (b) Kuño Tambo; (c) Hotel El Comercio; (d) Casa Arones**  
(© J. Paul Getty Trust).

of the project as representative of the earthen architecture in Peru. Cancino et al. (2013) conducted a campaign to inspect earthen buildings in different parts of the country, and finally selected a case study for each typology (Figure 1).

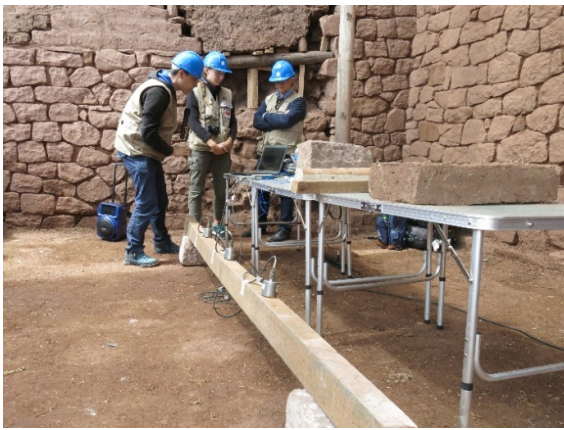
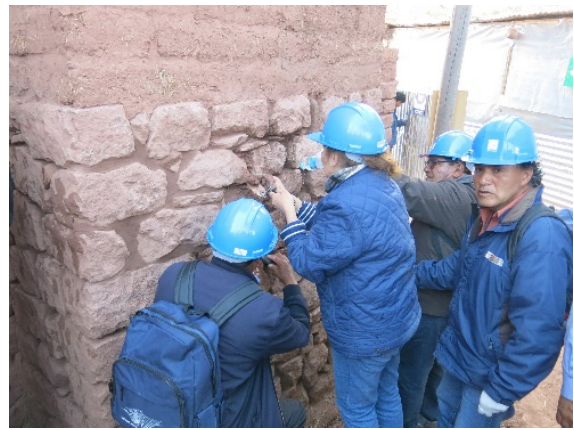
**Figure 5: Construction site visit during a seismic retrofitting workshop: (a) Lecture on non-destructive testing; (b) participants trying one of the mortar mixes for repointing a sample panel (© J. Paul Getty Trust).**

The final phase of the project included the implementation of the seismic retrofitting solutions in the prototype buildings, and dissemination to the professional community. In this context, a series of workshops on seismic retrofitting of earthen constructions took place in Cusco, Peru. Participants were asked to attend a two-day course, which included activities such as proposing and evaluating different available seismic retrofitting techniques, and discussing decision-making processes for seismic retrofitting design that weight architectural and engineering principles. Participants visited the construction site at the Kuño Tambo Church to observe some of the discussed retrofitting details (Figure 5). The site visit included two lectures on available non-destructive testing techniques and on re-pointing mortar specifications.

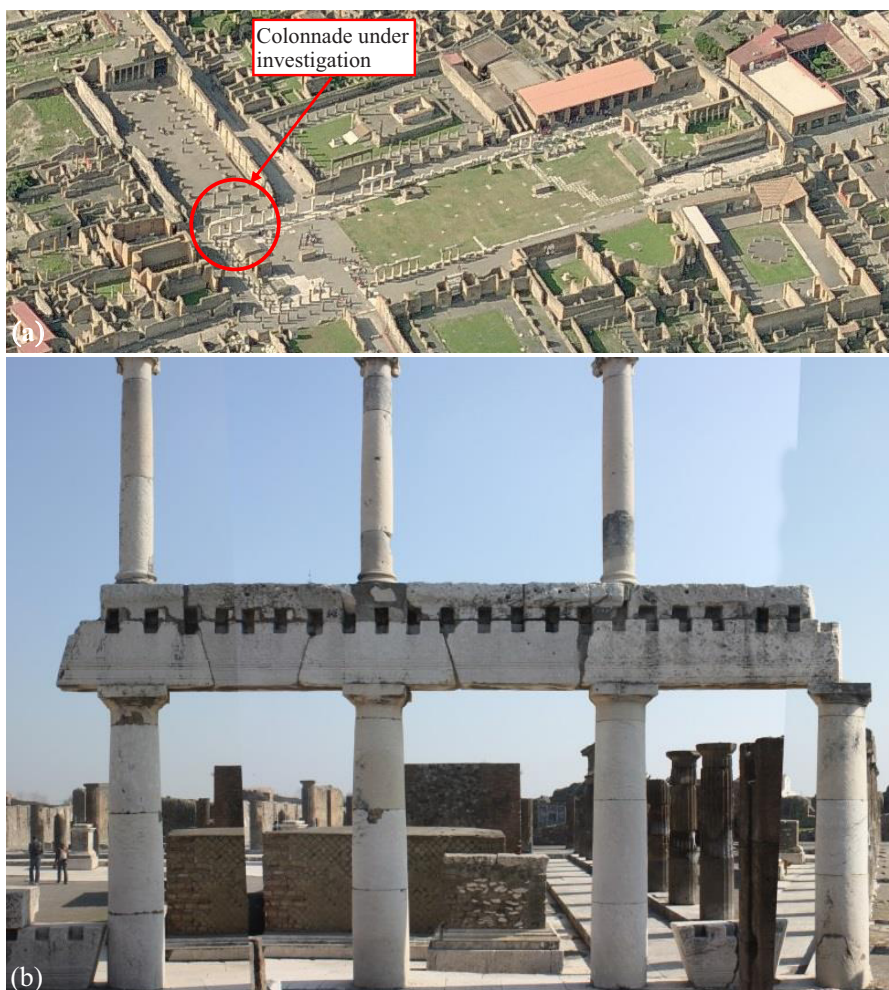
Figure 1: (a) The Forum in Pompeii: (a) Aerial view of the southern part of the Forum showing the colonnade under investigation, denoted with a red circle; (b) two-storey colonnade with multi-drum columns and multi-blocks segmented trabeation.

The structure under investigation is a two-storey colonnade of the Forum in Pompeii (Figure 1) made of white

limestone. The colonnade was erected in the main square of the ancient town, where political, economic and religious events were taking place. To prevent the passage of carts, the pavement was raised with respect to the height of the adjacent roads by two steps. It is believed that initially (i.e., VII–VI century BC) the Forum had an irregular shape. Today, the Forum has a rectangular shape with dimensions 143 m long by 38 m wide. Probably at the end of the II century BC, a double row colonnade was built, made of tuff. Some years later in 79 AD, the colonnade was reconstructed, and tuff was replaced with white limestone. The columns of the second storey followed the Ionic order, while the columns of the lower storey followed the Doric order. In the second half of the 20th century, only a small part of the second storey was re-erected for educational and touristic purposes. In 1980, an earthquake caused damage to the colonnades of the Forum, and it was decided to remove the beam over the second storey.

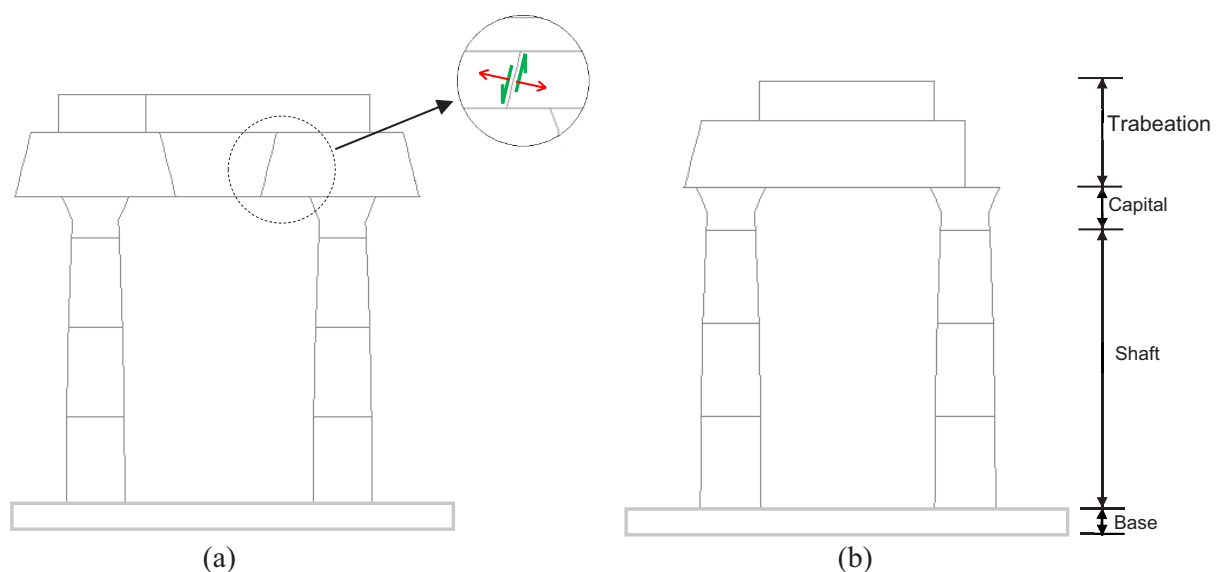
**Figure 2: Different construction methods for the trabeation of the Forum in Pompeii: (a) Flat arch (segmented beam); (b) solid long beam.**

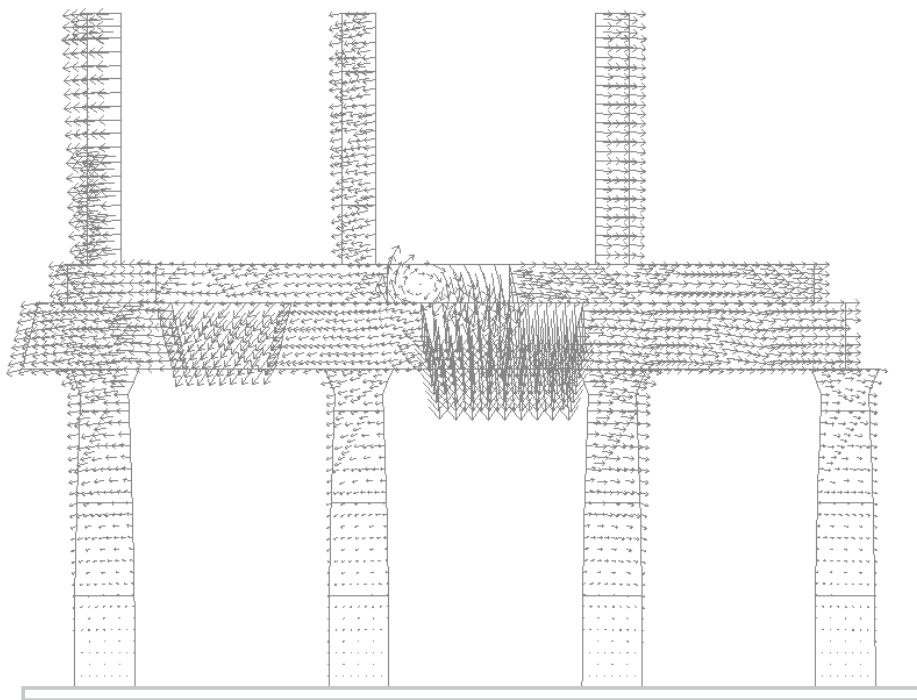
Figure 4: Displacement vectors ( $J_{fric} = 15^\circ$ ).

Figure 4 shows the displacement vectors in the colonnade when the joint friction angle is  $15^\circ$ . The displacement vectors clearly show the opening of the column joints in the lower storey, a result of the thrust of the segmented beam’s central blocks. The block at the central bay slides down

and pushes the contiguous blocks apart. Due to the sliding, the upper block tends to rotate and further pushes down the former. The upper storey columns follow the sliding of the blocks of the beam. In this context, stability is mainly a geometrical problem since the loss of support is the reason for collapse. On the other hand, the stress level at the limestone blocks is negligible.

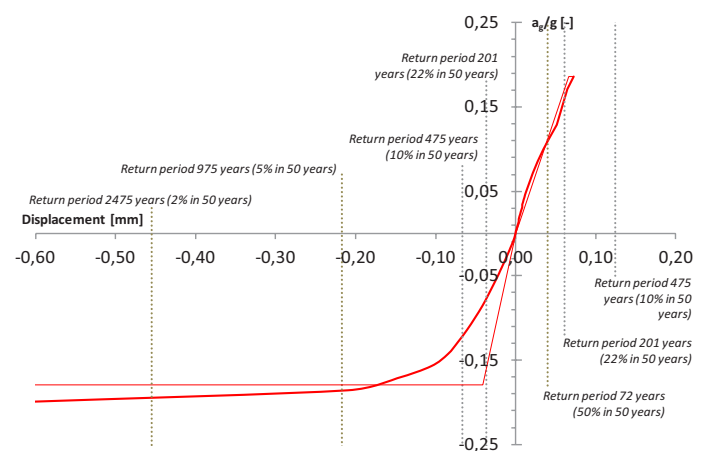
Figure 8: Comparison of the actual and bilinear capacity curve (average  $J_{fric} = 26.6^\circ$ ) with expected seismic demands (vertical dotted lines).

Figure 8 shows the pushover curves when the joint friction angle is equal to 26.6°. Dotted vertical lines represent the SDOF target displacements for different levels of ground motions (expressed in terms of return period and probability the ground motion will be exceeded in an

interval of 50 years). The colonnade is able to withstand a design earthquake with a return period of 200 years or 22% exceedance probability in 50 years, both in the positive and negative directions, and this performance is provided while the structure responds in the elastic range (Figure 8). In this sense, the capacity curves overlap in the two directions in the elastic range. Conversely, in the negative direction, where the structure exhibits a ductile behaviour, the spectral displacement is properly amplified to account for the limited strength of the colonnade, hence considering its displacement capacity after yielding in the nonlinear field.

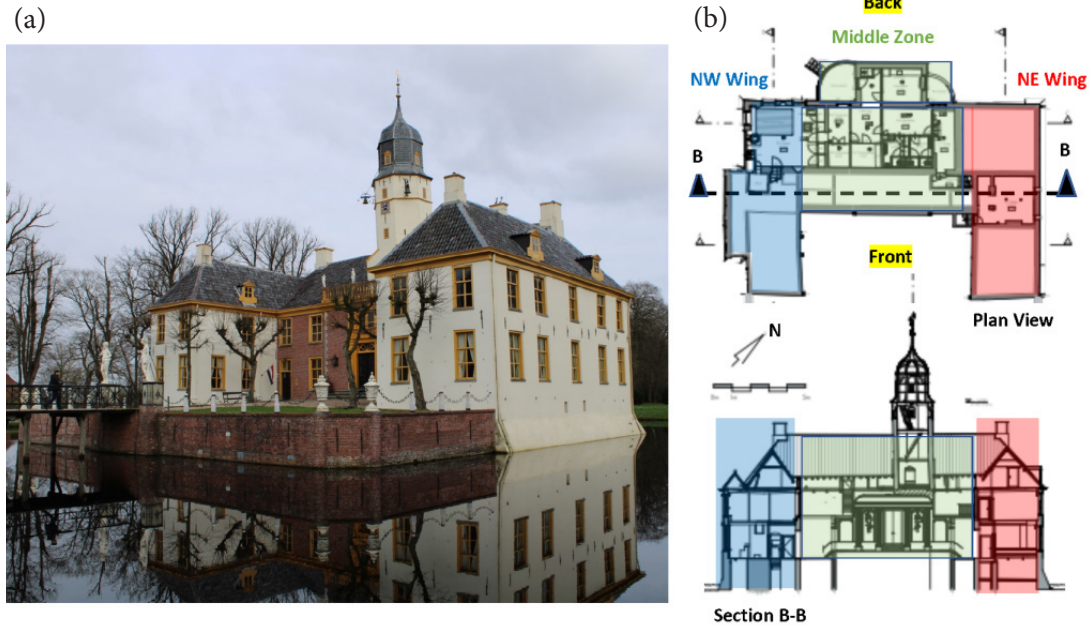
Figure 2: Fraylemaborg building: (a) Northeastern view; (b) plan view and cross-section.

Fraylemaborg (Figure 2) is the most emblematic historical building in the Groningen region. The structure

was firstly built in 1300 and sits on an artificial island surrounded by water channels, rendering the problem of earthquake response even more complicated (Dais et al., 2019). During the past induced seismic activity, Fraylemaborg suffered extensive damage. Two big restoration works took place recently at the end of 2015 and at the beginning of 2017 (Figure 3). Monitoring results and particularities in the case of induced earthquakes, as well as the usefulness and need of various monitoring systems for similar cases, are discussed by Bal et al. (2019b). ‘Weak’ soil properties dominate the structural response in the region. Thus, ground water monitoring and the interaction

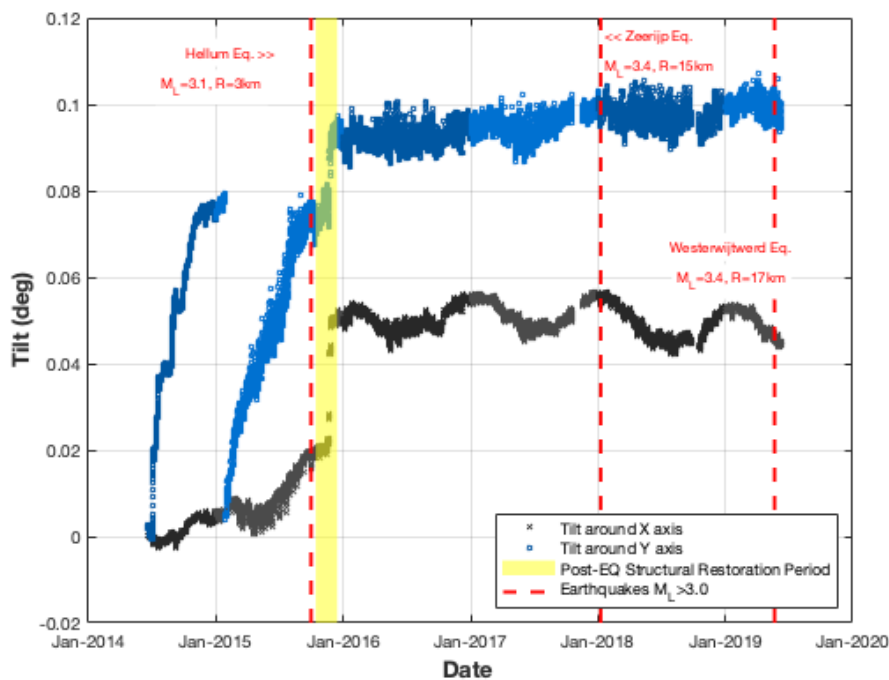
Figure 3: Tilt meter measurements since 2014, together with significant earthquakes and restoration periods for Fraylemaborg.

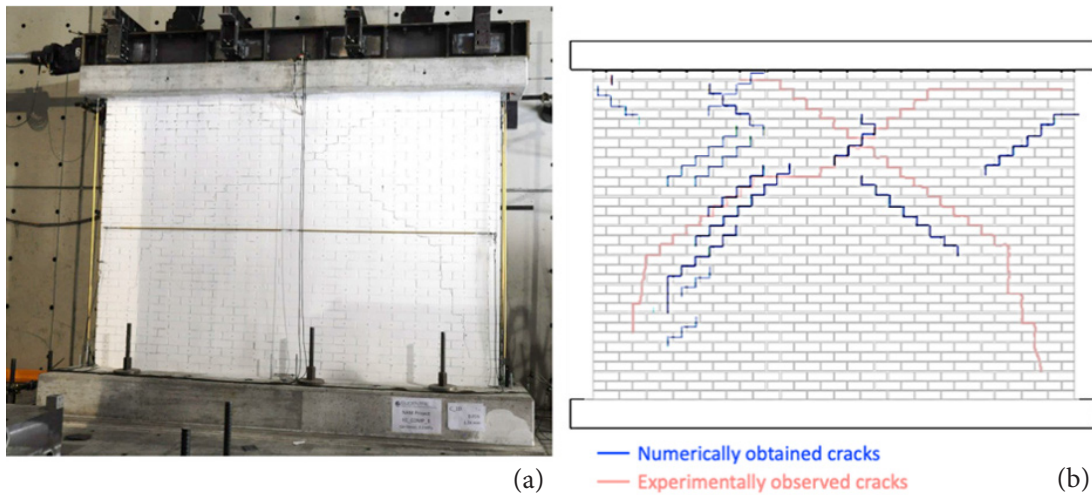
Figure 4: (a) Calcium-silicate URM (resembling typical walls found in the Groningen region) tested under cyclic horizontal load, and crack pattern at 0.05% drift (Graziotti et al., 2018); (b) comparison of experimental against numerical results in terms of observed crack patterns.

of damage when sequential time-history analyses are performed, unless stiffness and strength degradation issues are properly addressed (Dais et al., 2017). The overall results of numerical models, such as SDOF residual displacement or floor lateral displacements, may be misleading in understanding damage accumulation. On the other hand, detailed discrete-element modelling was found to be more consistent in terms of providing insights into actual damage accumulation (Sarhosis et al., 2019b). Sarhosis et al. (2019a) attempted to quantify the cumulative damage of URM subjected to induced seismicity. A numerical model based on the discrete element method (DEM) was developed, able to represent masonry wall panels with and without openings, found in domestic houses in the Groningen gas field (Figures 4 and 5). The numerical model was
