NEWSLETTER

Volume 9, No 1
Spring 1995

Field Investigation of the Kobe Earthquake

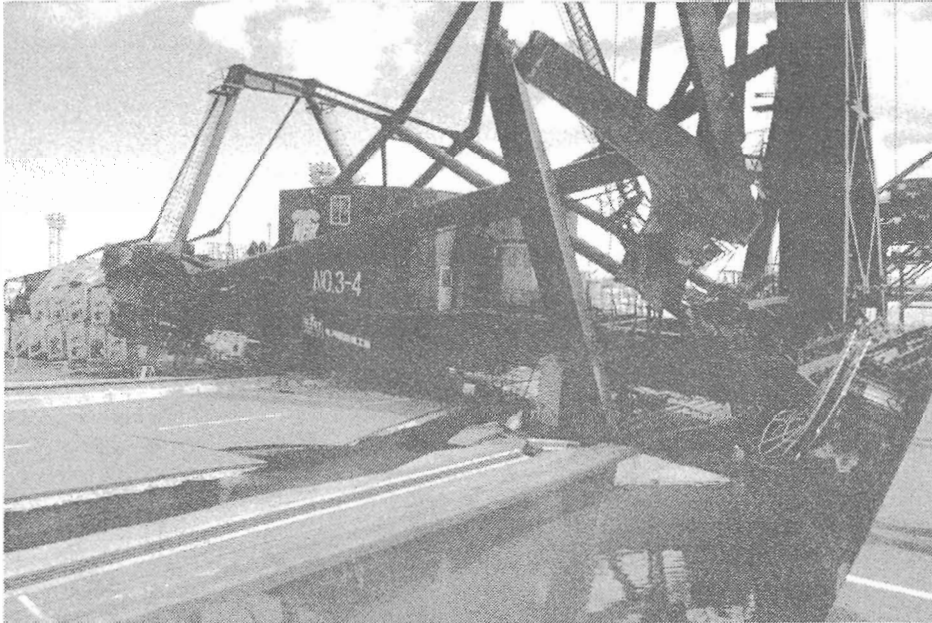
Overthrown derricks on Port Island

spreading of the dock walls. Some of the dock walls had moved laterally several meters buckling the legs of the cranes supported on them. A uniform settlement of about 0.5 m had also occurred over the whole of Port Island as the granular fill had compacted during the earthquake. The islands were completely man-made using rock from local quarries which had been dumped in-situ. It was this fill that had liquefied and compacted during the earthquake. One effect of this settlement is that those buildings with piled foundations now appear to poke up out of the ground by half a metre. Other structures on raft foundations appear to have settled with the soil and have suffered no obvious distress. I saw no cases where a foundation failure had directly caused structural damage although I saw several instances where warehouses had collapsed when dock walls had moved.
