## MODELLING THE DAMAGE TO THE MANCHESTER COURTS BUILDING IN THE CANTERBURY EARTHQUAKES SEQUENCE

**Abstract:** Seismic assessment of the Manchester Courts building is presented. This building was demolished following severe damage that resulted from the magnitude 7.1 Darfield earthquake (Canterbury, NZ) on 4 September 2010, amongst widespread objection from heritage supporters who believed that this historic building could be adequately reinstated. Finite element (FE) analysis was used to undertake a performance-based assessment using time-history analyses, and the accuracy of the model was validated by comparing the simulated results with benchmark experimental data and observed damage. The finite element model utilised two-dimensional (2D) elements in three-dimensional (3D) space and the macro modelling method was used.

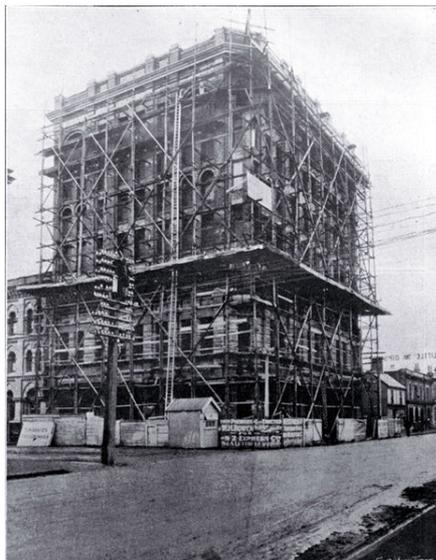
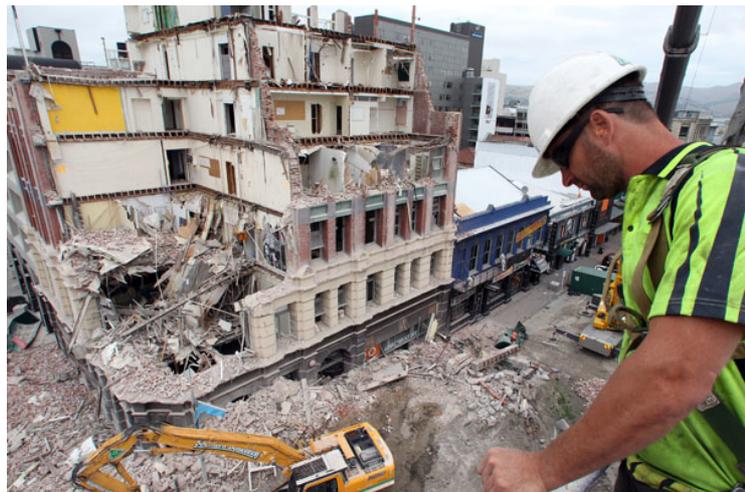
Figure 1. Early and final views of Manchester Courts

(a) Under construction in 1906  
([http://en.wikipedia.org/wiki/File:Manchester\\_Courts\\_under\\_construction.jpg](http://en.wikipedia.org/wiki/File:Manchester_Courts_under_construction.jpg))

(b) Under demolition in December 2010  
(<http://www.stuff.co.nz/the-press/news/christchurch-earthquake-2011/canterbury-earthquake-2010/4448192/Demolition-too-slow-say-critics>)

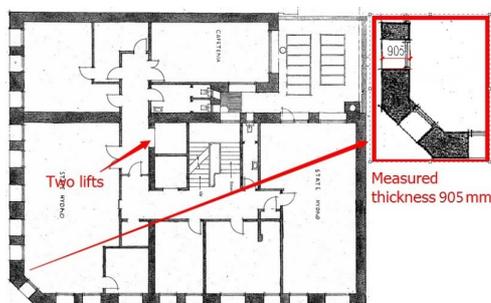
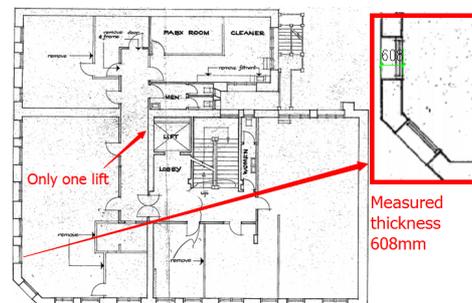
Figure 2. Representative changes over time to some structural elements

Manchester Courts had plan dimensions of approximately 20 m×23.6 m, with an approximate height of 37.1 m, but details of other structural elements were uncertain. As shown in Figure 2, many details of the building had changed over time due to building modifications. Consequently building geometric details were estimated from available photos (particularly those taken during demolition) and supplemented by aged design drawings.

(a) A design drawing of the second floor, July, 1951

(b) A design drawing of the second floor, February, 1969

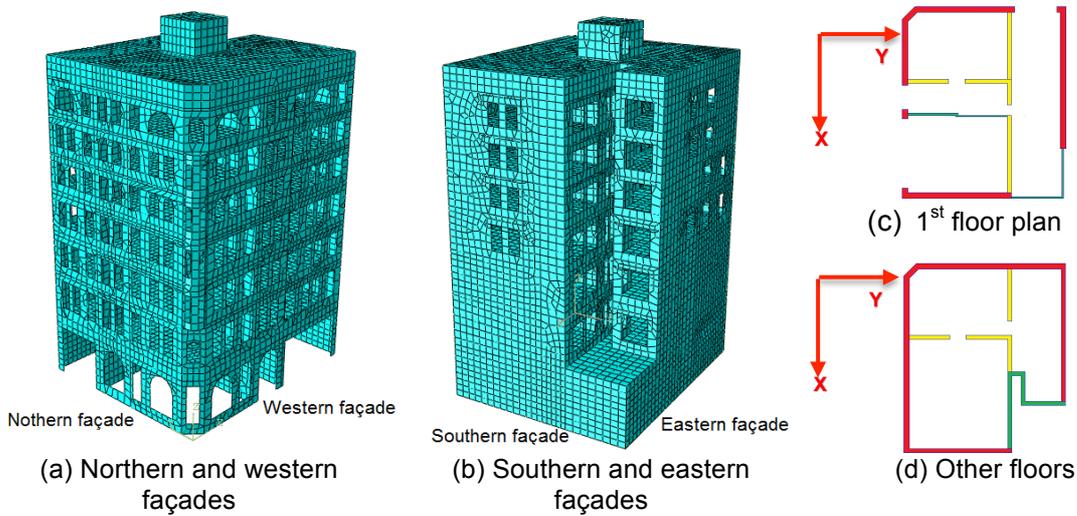
Figure 4: The meshed model and cross-section wall definitions of Manchester Courts

Once the building dimensions had been adequately estimated the FE model was generated (Figures 4a,b). Wall thicknesses are shown in Figures 4c,d and Table 1.

\* Different colours were defined for the walls to distinguish their thickness, see Figure 4.

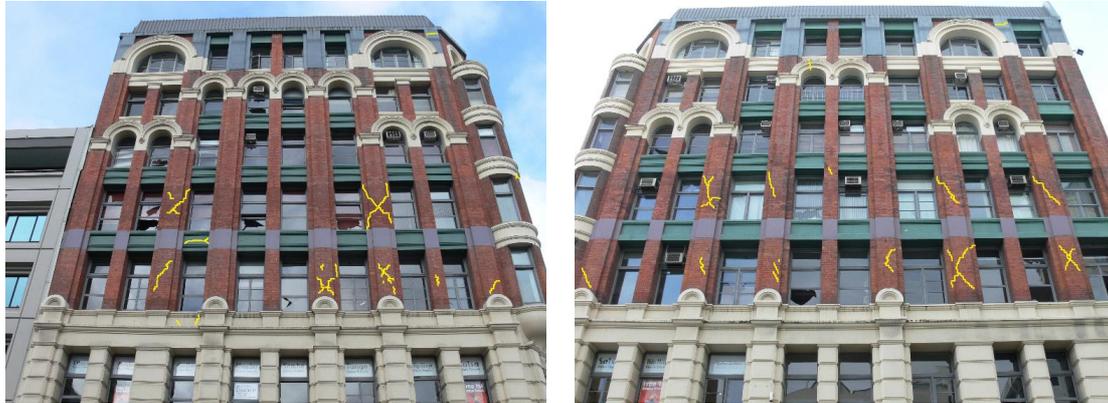
Figure 5: Pier crack patterns following the Sept 2010 Darfield earthquake  
(all cracks are shown enhanced for emphasis)

Building damage occurring in the Darfield earthquake is shown in Figure 5. The dominant cracking was diagonal stepped cracks observed in the piers of the northern and western façades at the 3<sup>rd</sup> and 4<sup>th</sup> floors. Less extensive cracking was also observed on the eastern and southern façades at the top of the building. No structural elements collapsed prior to demolition.

(a) Northern façade

(b) Western façade

A further verification was the comparison between the observed crack pattern (Figure 5) and that forecast by the model. In Figure 8 it can be seen that the model plastic strains mainly occurred in the piers of the 3<sup>rd</sup> and 4<sup>th</sup> floors, indicating that these piers suffered the most severe damage, corresponding with observations after the Darfield earthquake.

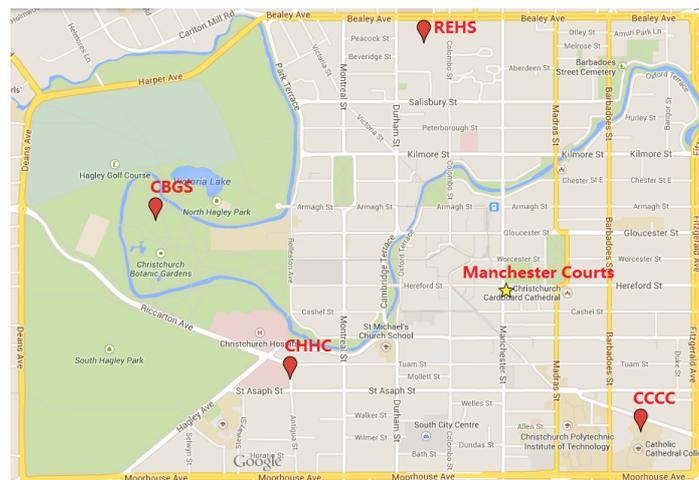
Figure 6: The locations of the ground motion stations and Manchester Courts

As shown in Figure 6, four strong motion stations (SMS) in Christchurch city were located around Manchester Courts, referred to as CBGS, CCCC, CHHC and REHS, with the distances between each SMS and Manchester Courts being in the range of 0.88 km to 1.64 km. Cubrinovski et.al (2011) and Cubrinovski et.al (2013) compared the characteristics of the seismic data for the Darfield and Christchurch earthquakes which were obtained from the four SMS, and found that the pseudo-spectral acceleration and spectral displacement amplitudes were similar. Moreover, Cubrinovski et.al (2013) demonstrated that the SMS in Christchurch city were located on D class soil as defined in the NZS 1170.5 (Standards New Zealand, 2004). Consequently it was deduced that the seismic data from all 4 SMS were relevant to the current study.

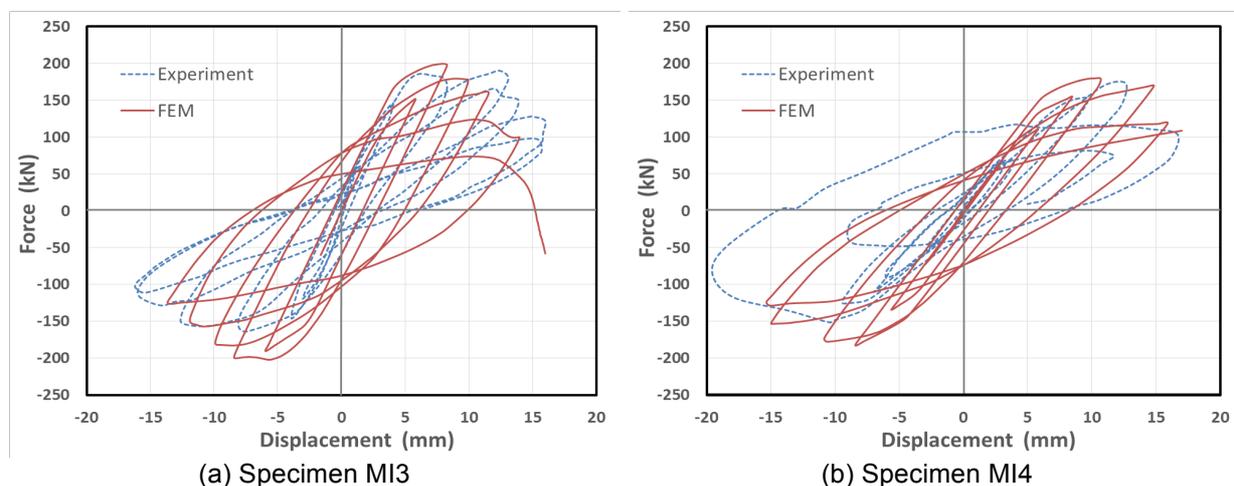
Figure 7: Comparisons between FEM results and for testing by Magenes et al. (1992)

Three structural performance levels as defined in Eurocode 8 (European Committee for Standardization, 2004) were considered in order to conduct seismic assessment using a performance-based approach, being damage limitation (DL), significant damage (SD) and near collapse (NC). For shear failure of primary masonry components the drift limits for DL, SD and NC are 0.1%, 0.4% and 0.53% respectively. The aspect ratio of the most heavily damaged piers was approximately 2.2:1 (height to width), and so test results of clay brick masonry piers with a similar aspect ratio (2:1) (Magenes et.al 1992) were used to validate the modelling method. Figure 7 shows good agreement between the experimental cyclic behaviour and the finite element models.

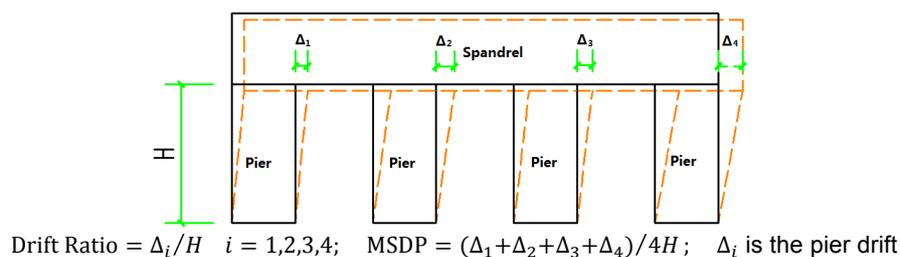
Figure 9: An example of masonry piers and spandrel

To assess performance levels a ‘mean storey drift of piers’ (MSDP) parameter was introduced as shown in Figure 9, based on reference points located at the top and bottom of each pier, such that the governing height was the pier height rather than the storey height.

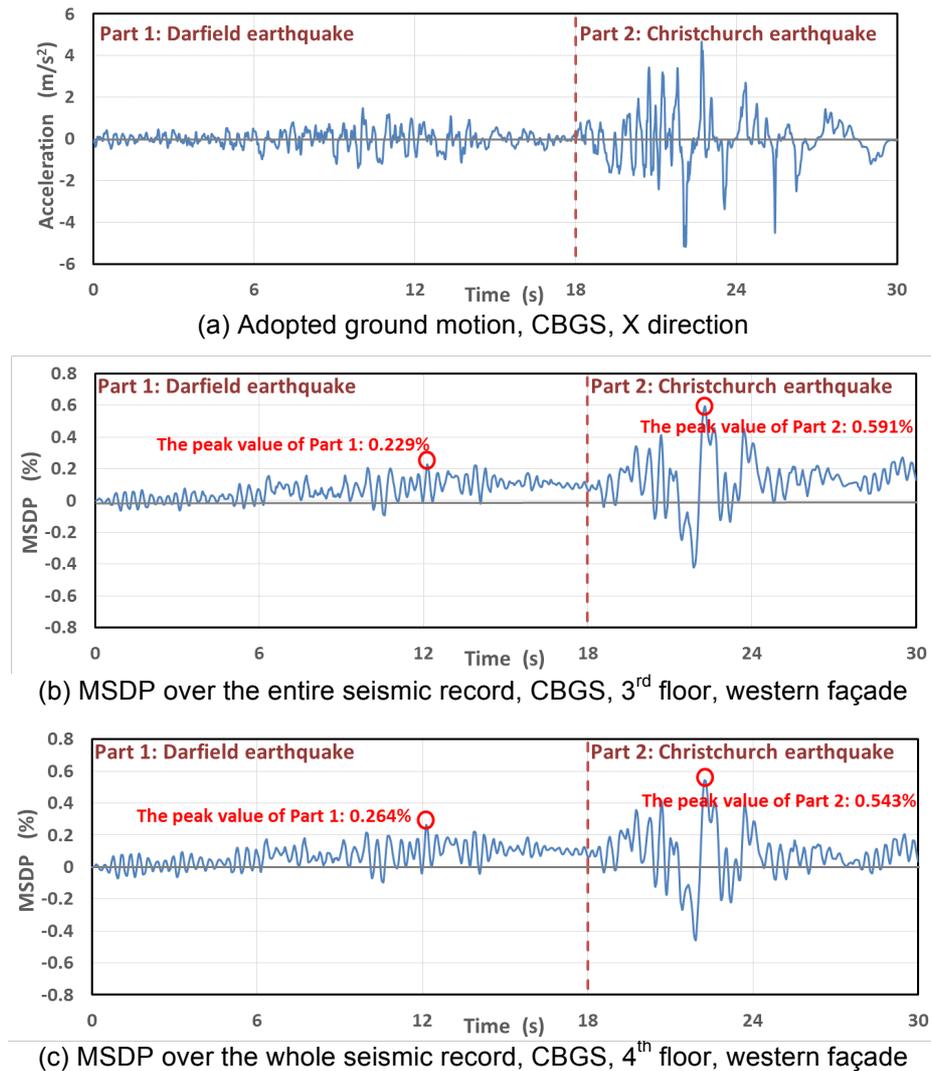
Figure 10: an example of the seismic data and response

Figure 10a shows the seismic data measured at CBGS (X direction), with the corresponding MSDP of the western façade at the 3<sup>rd</sup> and 4<sup>th</sup> floors shown in Figure 10b, c. The peak value of MSDP was chosen as the governing parameter for the performance-based analyses because no significant spandrel damage was observed and global response appeared to be exclusively dictated by pier behaviour, as shown in Figure 5 and Figure 8. For a typical pier height of 2.6 m and a typical storey height of 4.4 m (see Table 1) the effective storey drift is approximately 60% of the MSDP, dependent on the extent of spandrel deformation. Although only the X-direction motion is shown in Figure 10, all three components of recorded ground motion were used in the finite element time-history analyses. In Figure 10b the peak value of MSDP for Part 2 of the motion input is 0.59%, exceeding the adopted NC state of 0.53%.

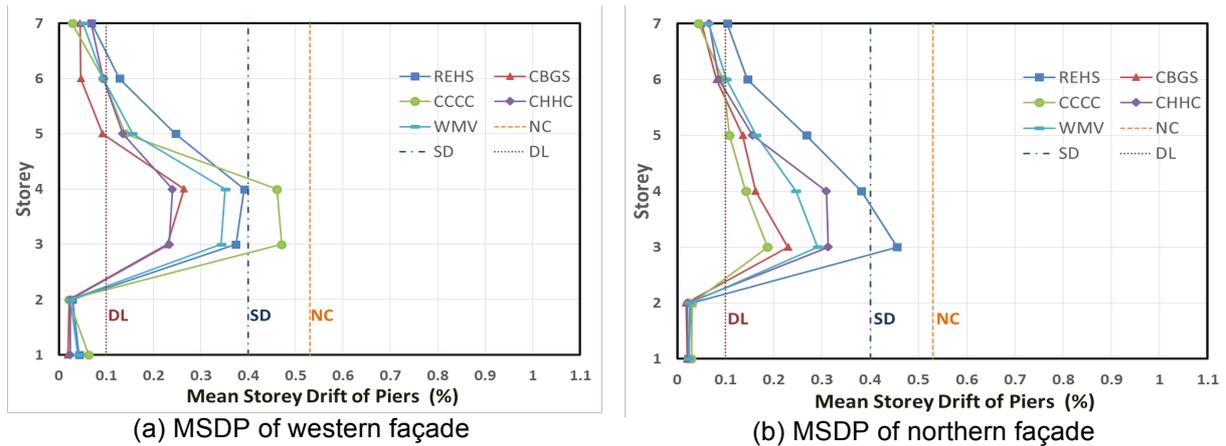
Figure 11: Peak values of the mean storey drift of piers, 2010 Darfield earthquake

Figure 11 demonstrates that in the Darfield earthquake no MSDP exceeded the NC state (0.53%) and that most MSDP were less than the SD state (0.4%), suggesting that the piers of the model would not collapse (corresponding with observed response). The MSDP of the 3<sup>rd</sup> and 4<sup>th</sup> floors were much greater than those of other floors and well in excess of the DL state (0.1%), indicating that these piers were forecast to be severely damaged. All simulation results were in accordance with the observed performance described in the damage report (Ingham & Griffith, 2010). The weighted mean value (WMV) was introduced to represent the overall performance of the building, with the weighting being the reciprocal of the distance between each SMS and Manchester Courts.

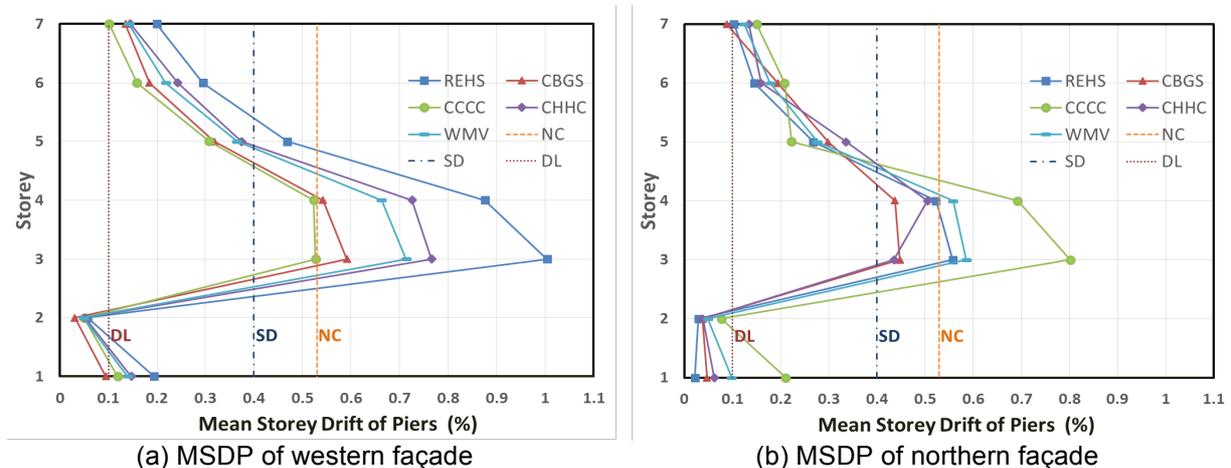
Figure 12: Peak values of the mean storey drift of piers for the 2010 Darfield earthquake and 2011 Christchurch earthquakes combined

Figure 12 presents the MSDP obtained from the model when subjected to 100% of the Darfield earthquake followed by 100% of the Christchurch earthquake. It is seen that the maximum MSDP occurred in the 3<sup>rd</sup> and 4<sup>th</sup> floors, and that regardless of which seismic data was used, at least two MSDP in one façade were over the NC state (0.53%), indicating that the piers would collapse. In addition, the distribution of MSDP can be summarized using their WMV, which were all in excess of the NC state. Note that the MSDP are related to the drifts of piers in the whole storey, not those of a single pier. Consequently, the collapse would occur in most piers of the 3<sup>rd</sup> and 4<sup>th</sup> storeys. In Figure 12a all MSDP of the 3<sup>rd</sup> floor are greater than those of the 4<sup>th</sup> floor, indicating that in the western façade the pier collapse would start from the 3<sup>rd</sup> floor. For the northern façade, Figure 12b shows a mix of peak MSDP between the 3<sup>rd</sup> and 4<sup>th</sup> floors.

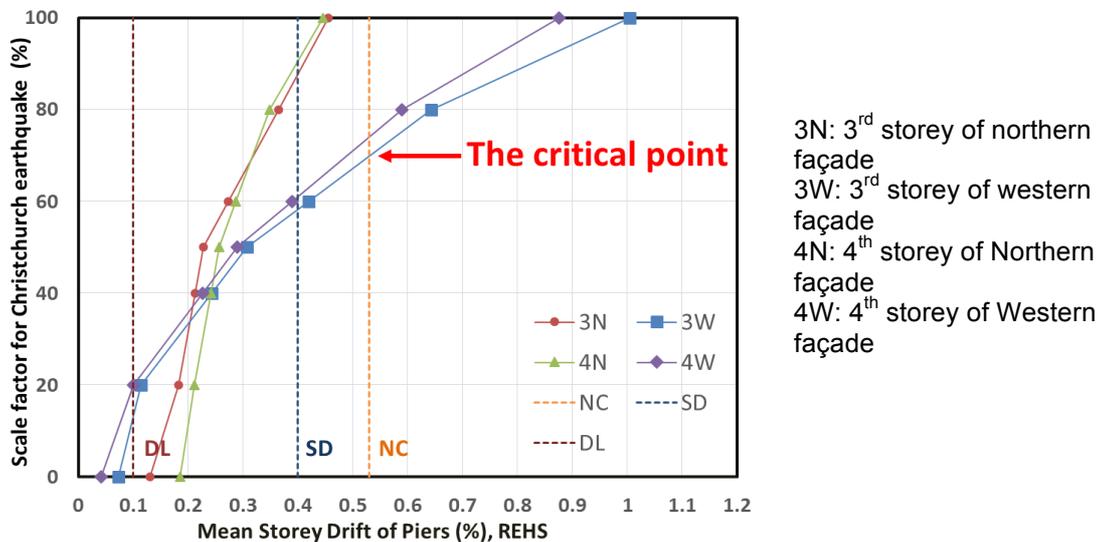
Figure 13: An example of IDA curves

The study was concluded by undertaking incremental dynamic analyses (IDA) to investigate the forecast level of shaking necessary to initiate collapse on 22 February 2011, by beginning the analysis with the building already damaged following the Darfield earthquake. Figure 13 demonstrates the IDA results using scaled REHS data. The initial MSDP of the IDA curves are non-zero because of the residual drifts caused by the Darfield earthquake. The IDA curves of the western façade exceeded the NC damage state and those of northern façade did not. It is seen that the western façade of the 3<sup>rd</sup> storey was the forecast location for the onset of collapse because the corresponding IDA curve exceeded the NC state at 70% of the unscaled earthquake input. Table 3 shows the critical scale factors for each of the four

considered ground motion stations (see Figure 6), indicating that the Near Collapse (NC) damage state was reached in a range of 69.9% to 92.4% of the unscaled records. Considering the WMV weighted ratio, the critical scaling factor was 81.5%.

Seismic data	CBGS	CCCC	CHHC	REHS	WMV
Scale factor for Christchurch earthquake	92.4%	79.3%	82.1%	69.9%	81.5%
Collapse location*	3W	3N	3W	3W	3W
