# NEWSLETTER

Volume 28 No 1  
March 2017

## EEFIT Special Issue

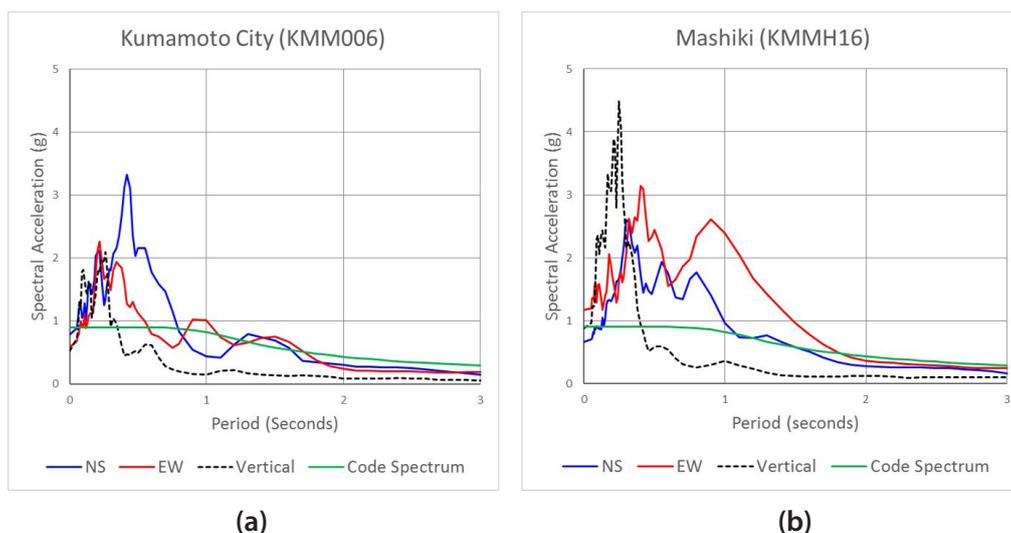
Two large-magnitude earthquakes occurred on 14 and 16 April 2016 in central Kyushu Island, southern Japan (Figure 1). Sudden right-lateral motion of up to two metres on the Hinagu and Futagawa faults generated the Mw 6.1 foreshock and Mw 7.1 mainshock, respectively (Figure 2). The primary effect of the earthquake ground shaking and the secondary landslides, which were triggered by the earthquakes, in combination with the double shock impact, caused significant and widespread damage and disruption to the urban and rural regions of Kumamoto and Aso respectively. The measured ground motions exceeded the code design values by a factor of up to 3, as shown in Figure 3.

**Figure 3: Measured ground accelerations compared to the code spectrum in (a) Kumamoto City Centre, and (b) Mashiki Town.**

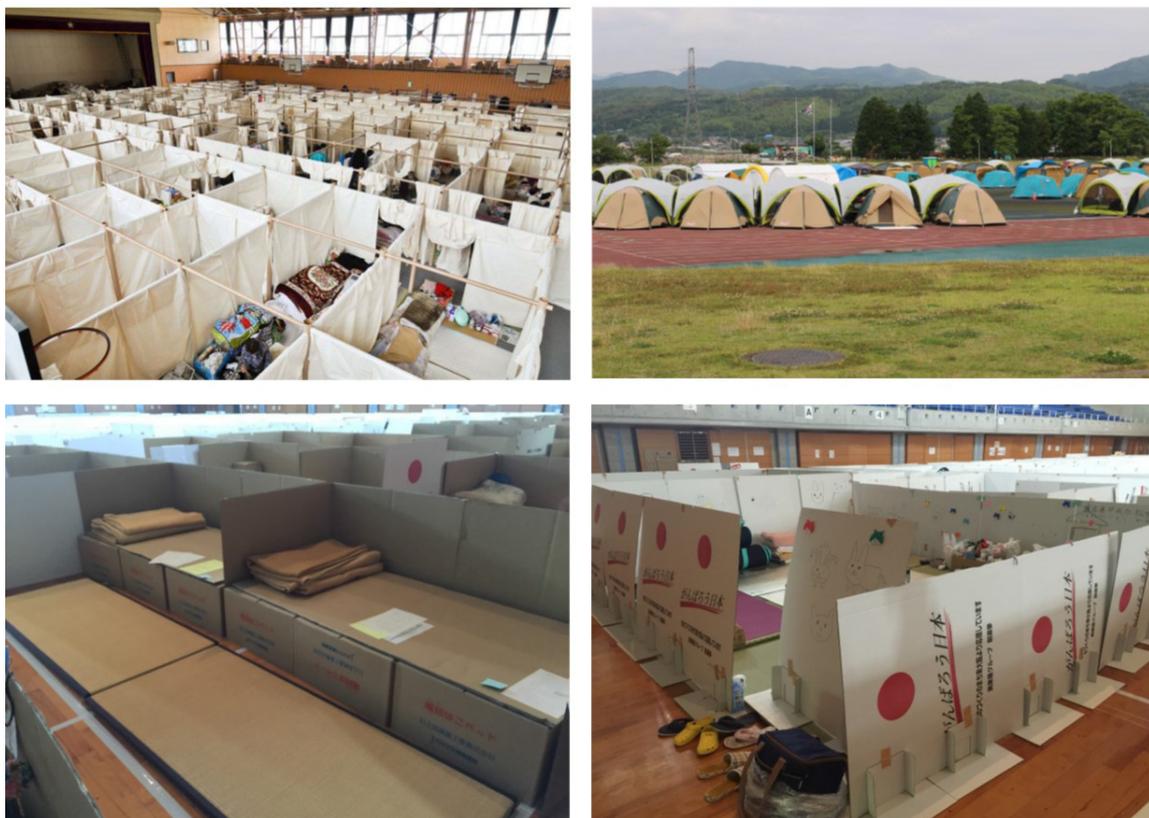
In terms of relief and recovery, interviews with official and voluntary emergency response personnel in addition to evacuees indicated that the rate of recovery and the ability to ‘build back better’ may be dependent on the approach employed by the different municipalities affected by the earthquakes. A day after the mainshock, there were 855 shelters and 183,883 evacuees recorded. The various evacuation centres typically housed three types of people: people with partially collapsed or completely collapsed houses; people living in residential blocks with disrupted services, and those who were too scared to return home. The affected municipal governments provided gymnasiums, schools and other public buildings for use as public shelters (Figure 9).

Figure 9: Various evacuation centre temporary settlements erected after the Kumamoto earthquakes.

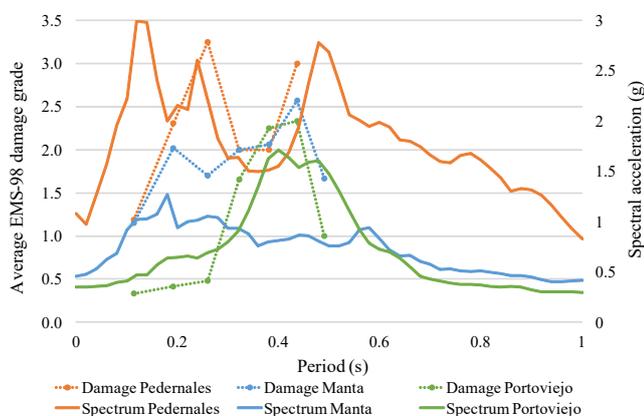
and buildings with certain heights (and hence estimated fundamental periods (CEN, 2004)), as shown in Figure 4.

Figure 4: Relationship between response spectra from recorded ground motions and surveyed damage.

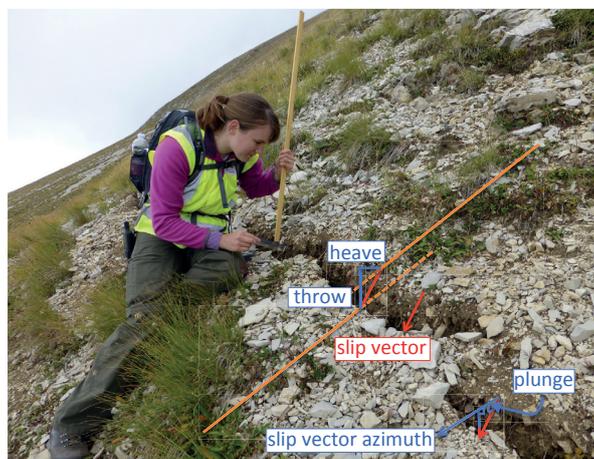
Slip at depth on the fault plane that generated the main shock propagated to the surface and offset the hillside of Mt Vettore (~20 km north of the town of Amatrice). The offsets seen were in the range of 3–30 cm along a 5 km long section of the fault. The mission mapped part of the surface rupture, adding to observations made by colleagues from UCL, Leeds, Durham and several Italian institutions. This involved taking measurements of the throw (vertical offset), heave (horizontal offset) and slip (total offset), the orientation of the rupture and the slip direction (Figure 1). This data will be used to study the relationship between the size of the offset and the geometry of the rupture.

Figure 1: Explanation of measurements taken in the field.

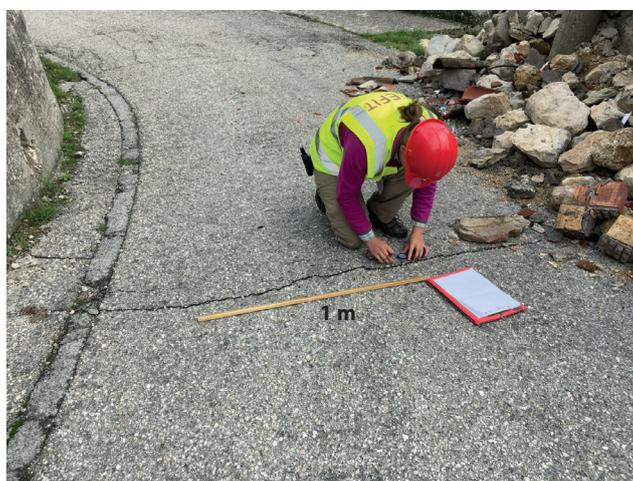
As well as primary surface ruptures, the earthquake also generated secondary environmental effects, including landslides, rockfalls and ground cracks. By mapping out the location of these effects and the size or volume, an intensity level (similar to the European Macroseismic Scale, EMS) can be determined. The benefit of the ESI (Environmental Seismic Intensity) scale is that it can be applied anywhere within an affected area and does not introduce a built environment bias (see Figures 2 and 3). The team travelled around the epicentral area recording these effects, focussing on the areas around the towns of Amatrice, Accumoli and Arquata del Tronto. They observed many effects around the towns of interest, mainly landslides and rockfalls with fewer ground cracks and hydrological effects. Using these

Figure 3: Measuring secondary environmental effects.
